Great Hill Tunnel and Pipeline Restoration Project

NASTT Northeast Chapter Technical Forum

Rose M. Gavrilovic, P.E. and Orville A.D. Kelly
South Central CT Regional Water Authority
November 13, 2018

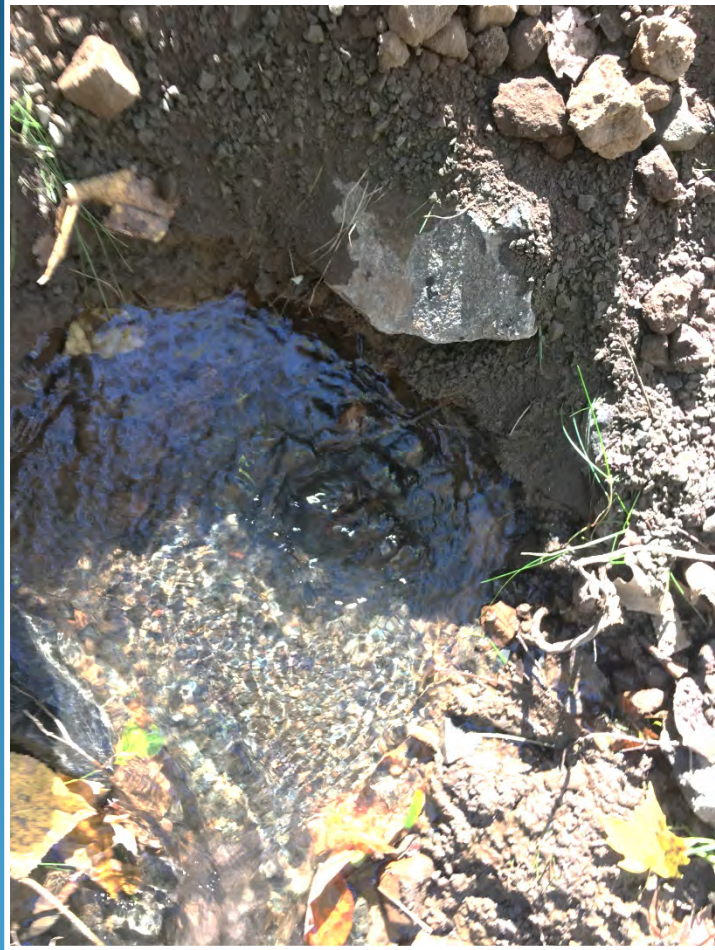
New Boil Area

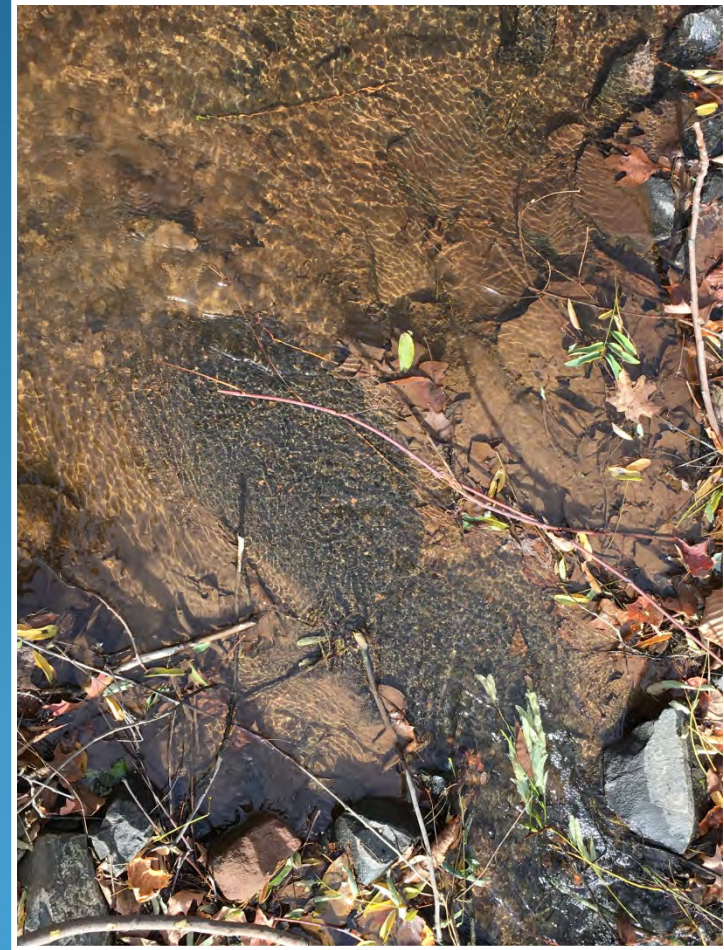
Pipe Bedding Material

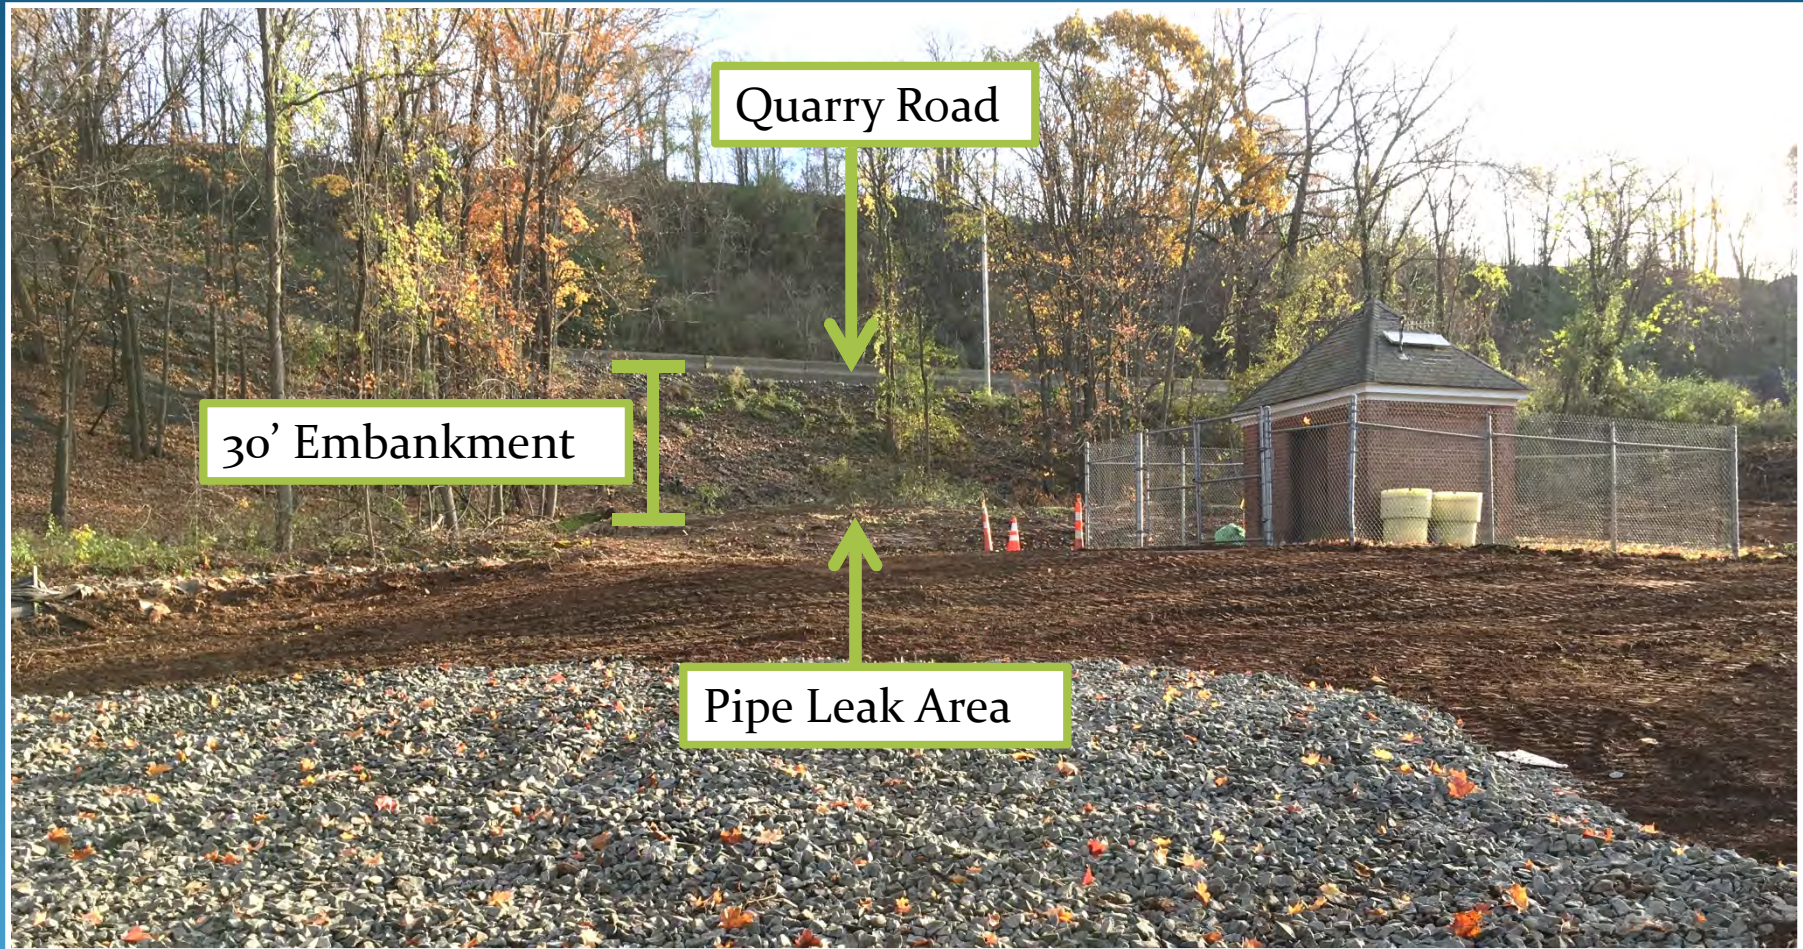
Area of Pipe Leak

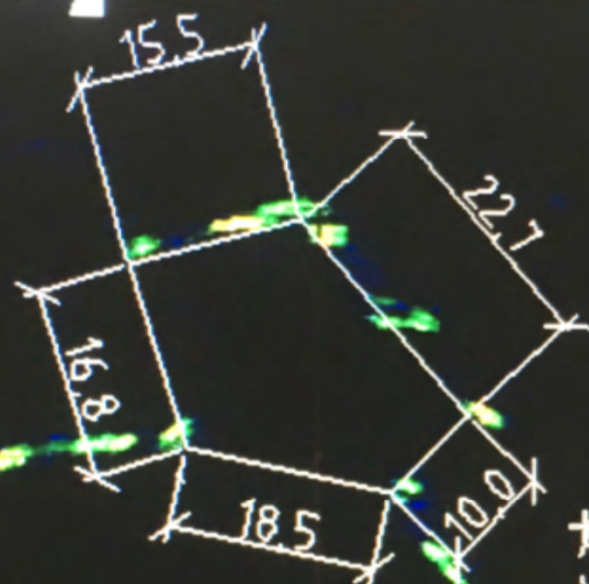
Profiling Sonar Image recorded
at Station 28+66

Area: 3.1 ft^2
Volume: Assuming
breach is 3ft deep
volume = approx 9.1 ft^3

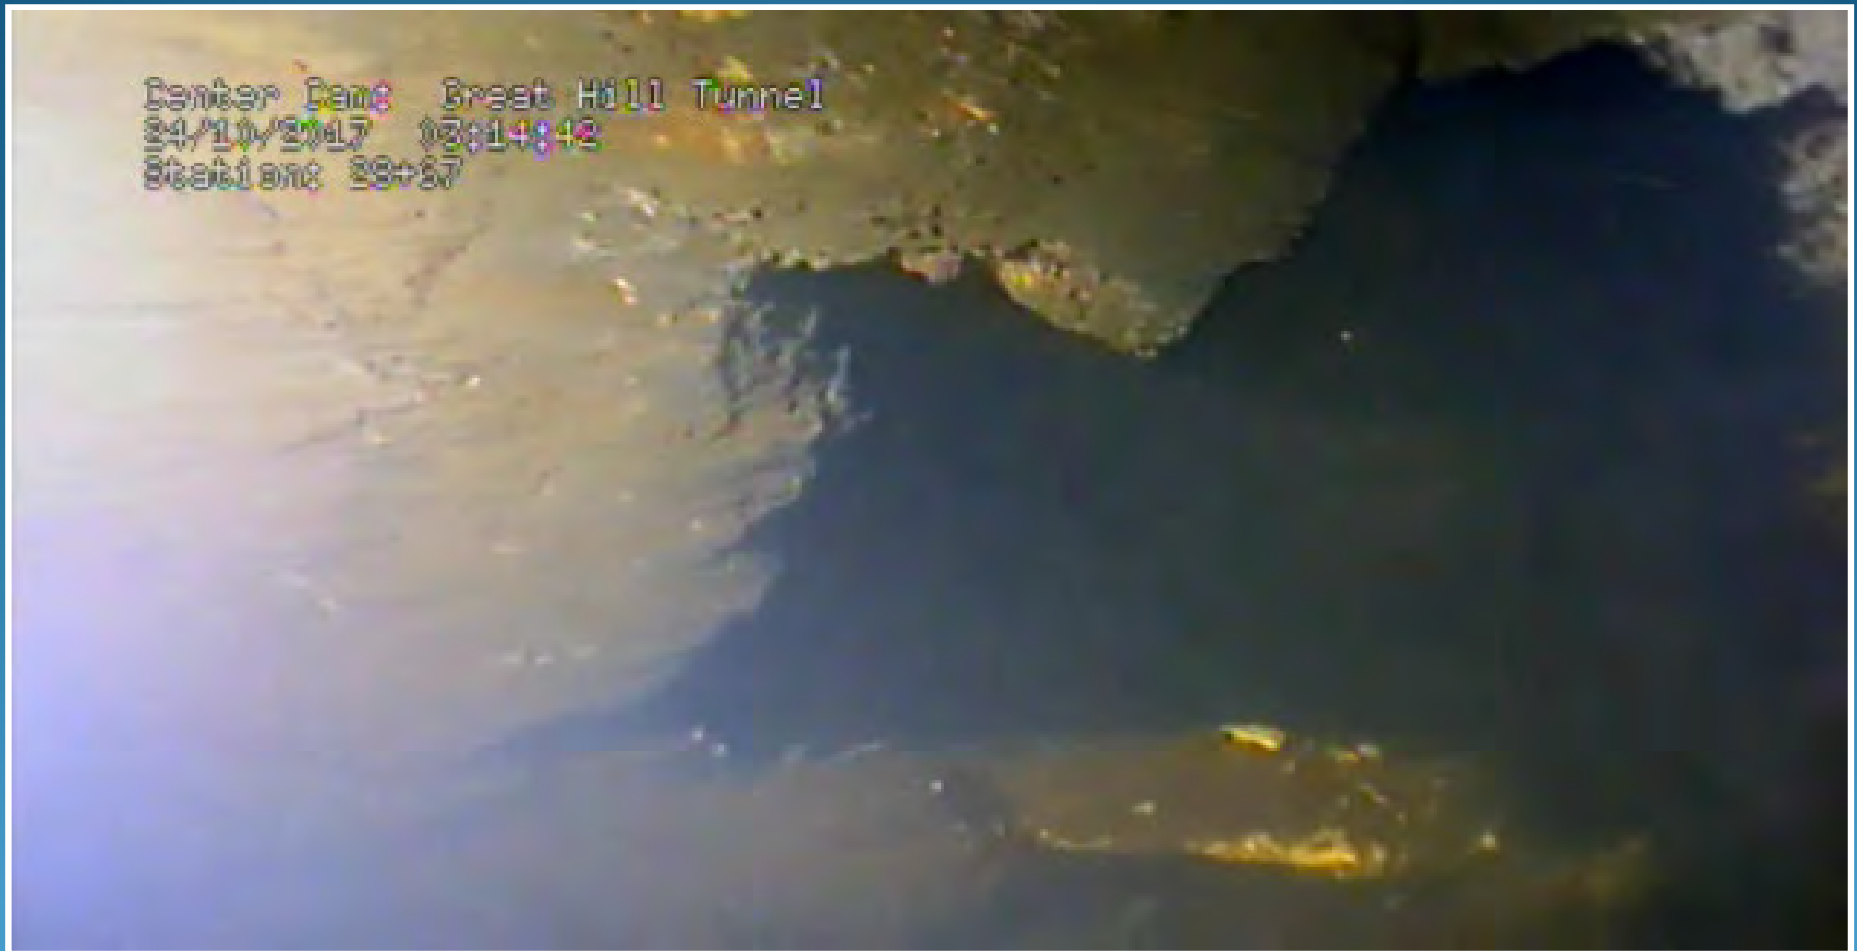
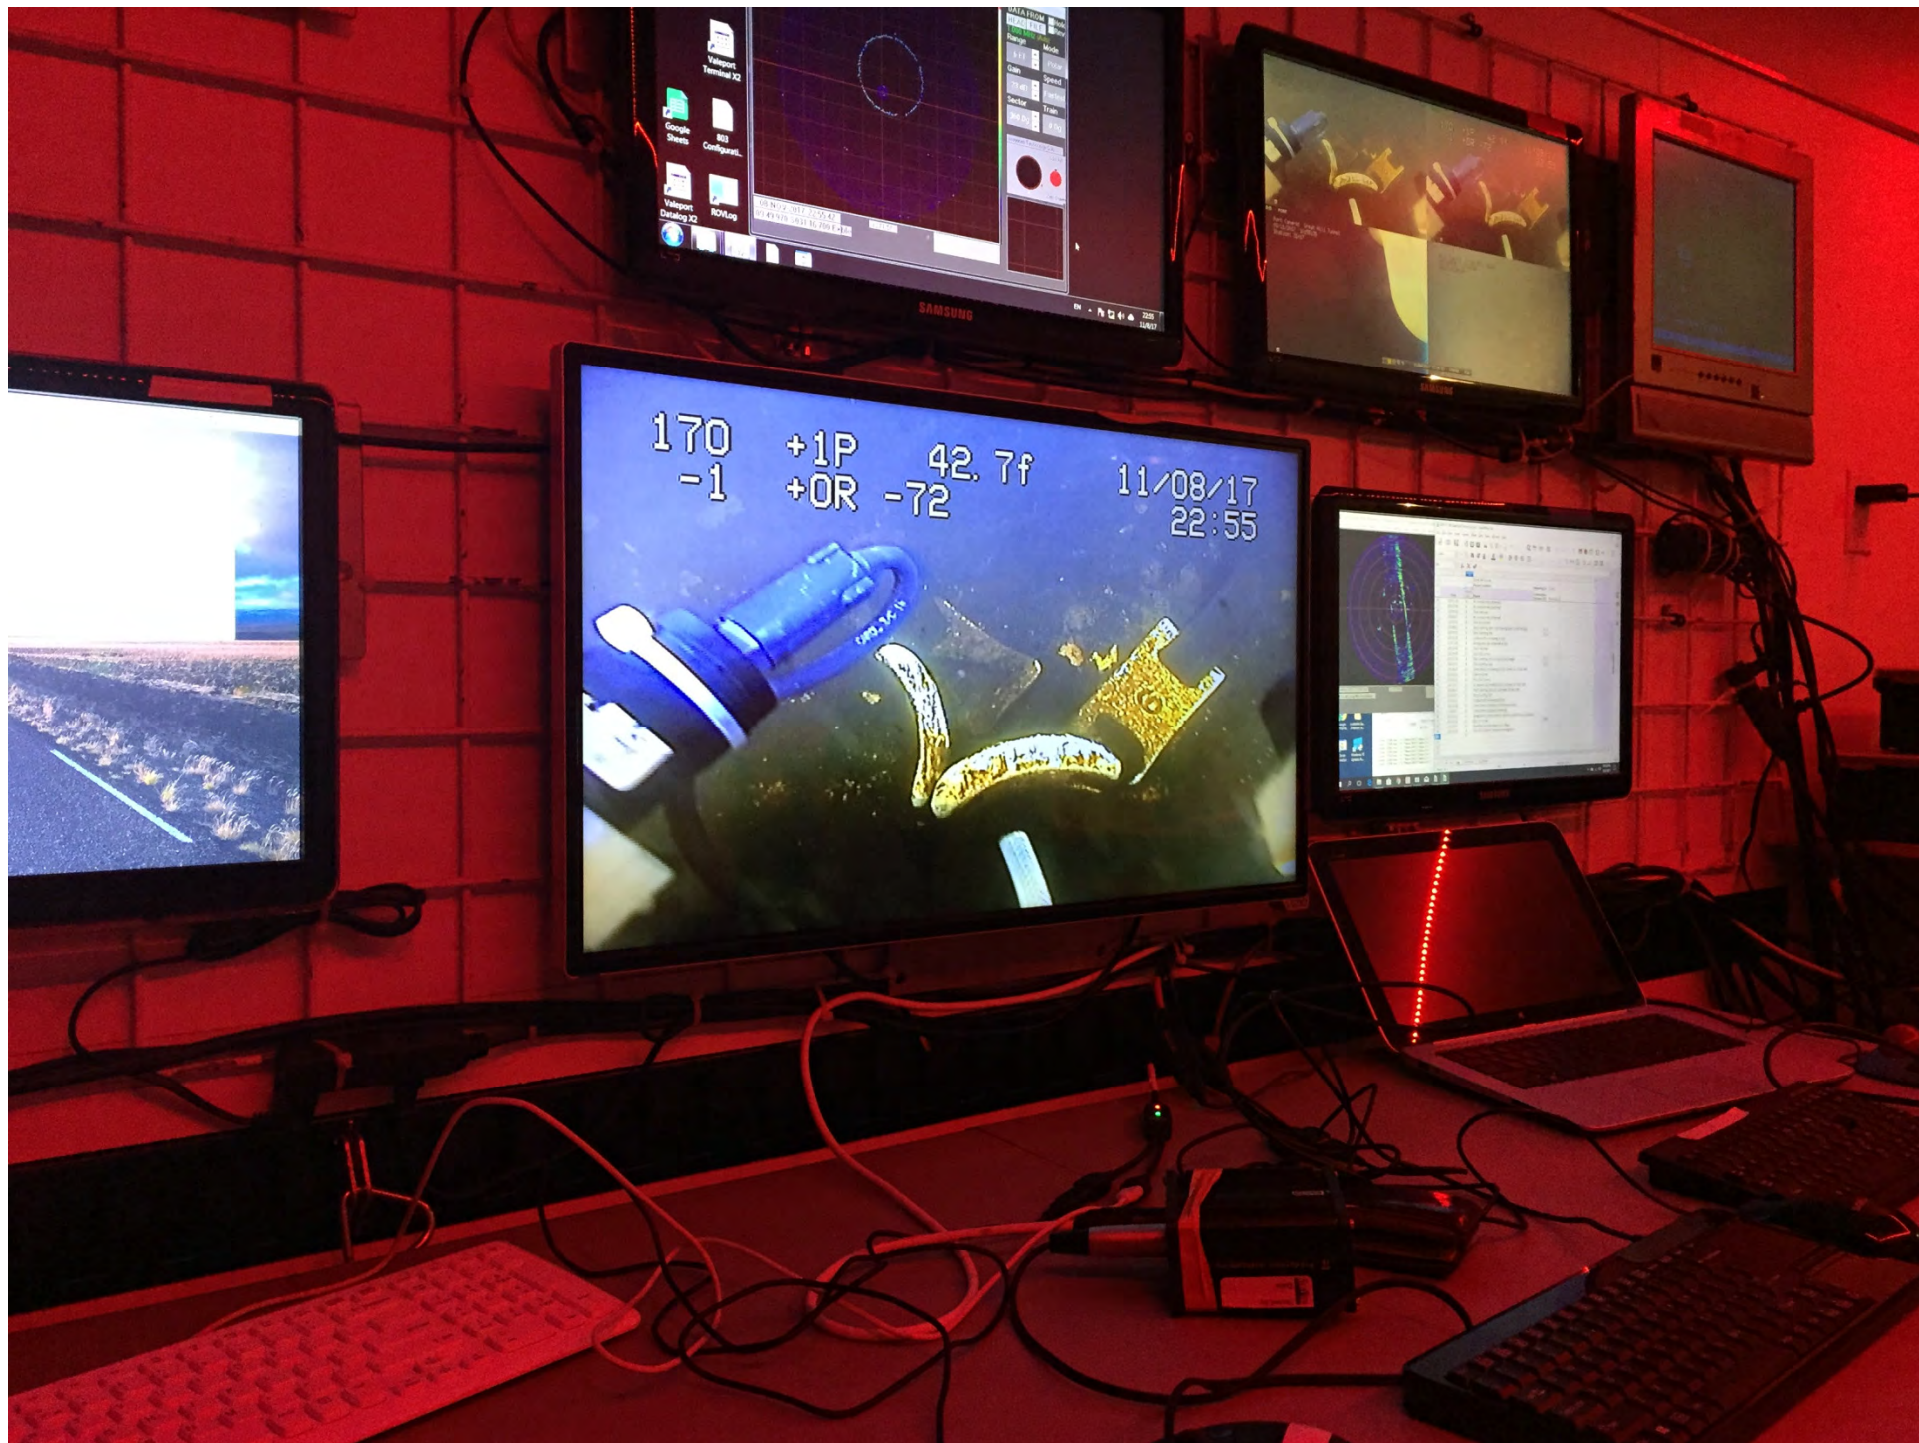
Great Hill Tunnel Defect

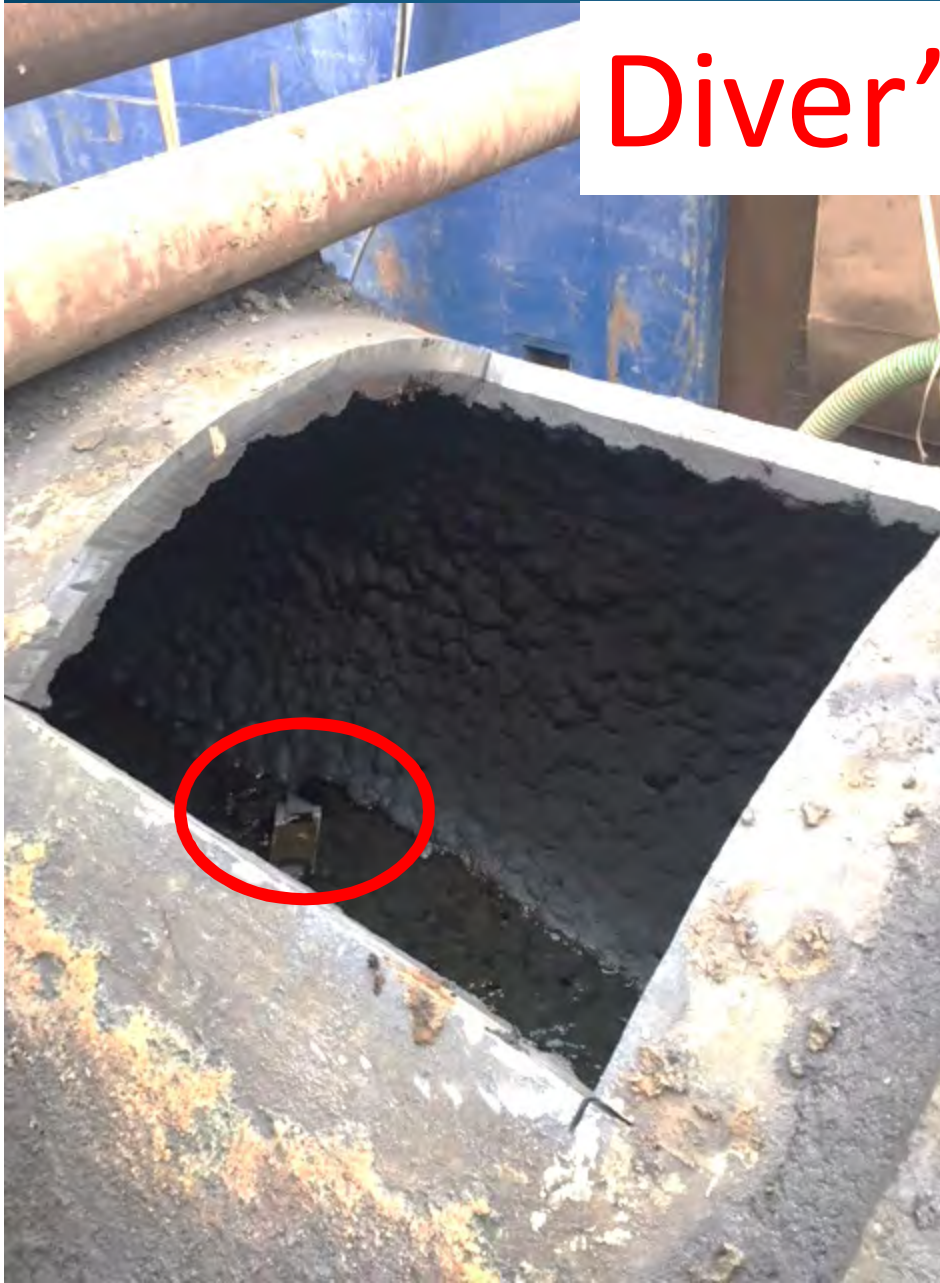
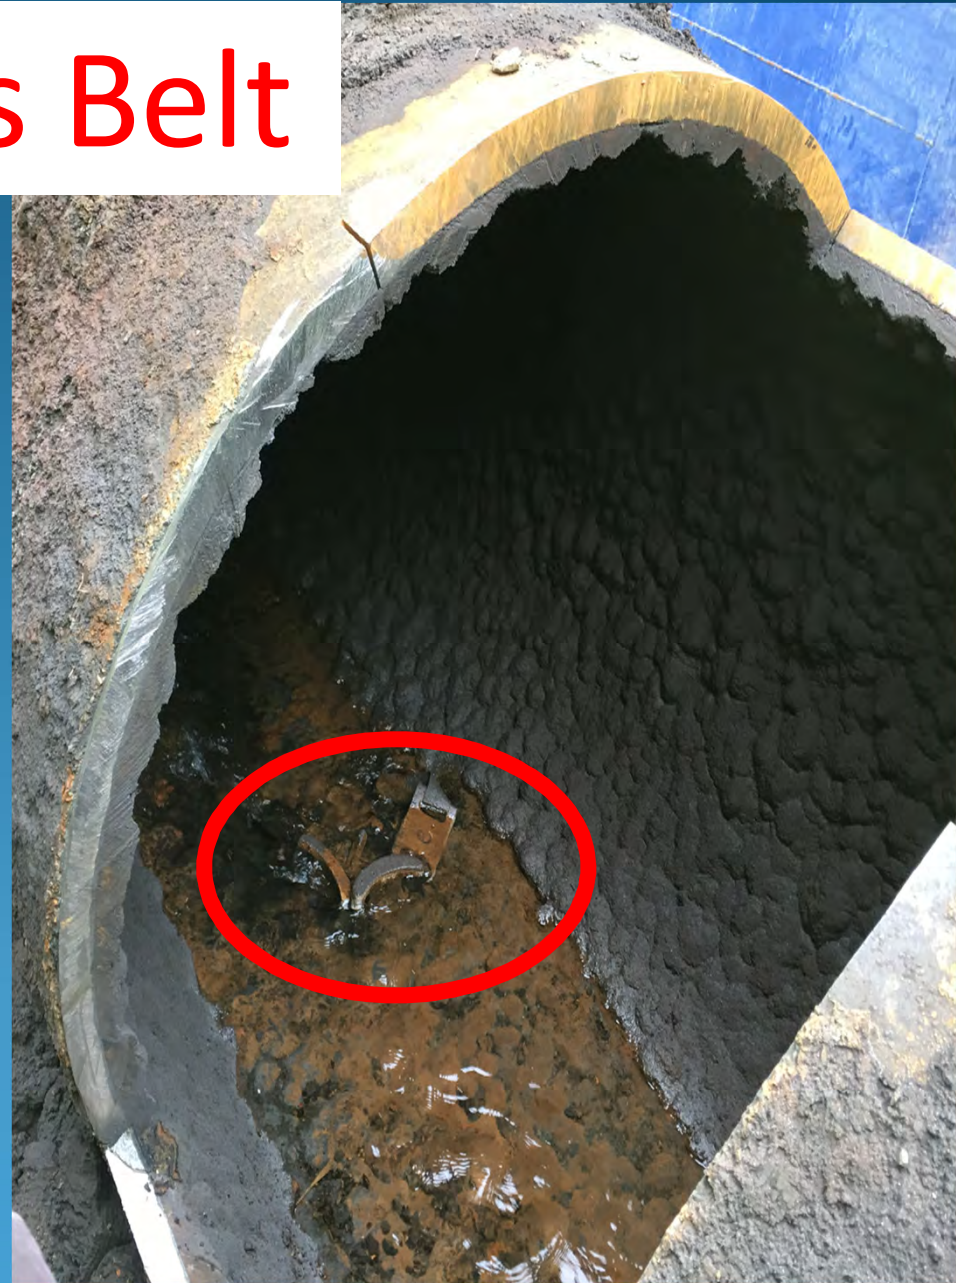
Diver's Belt

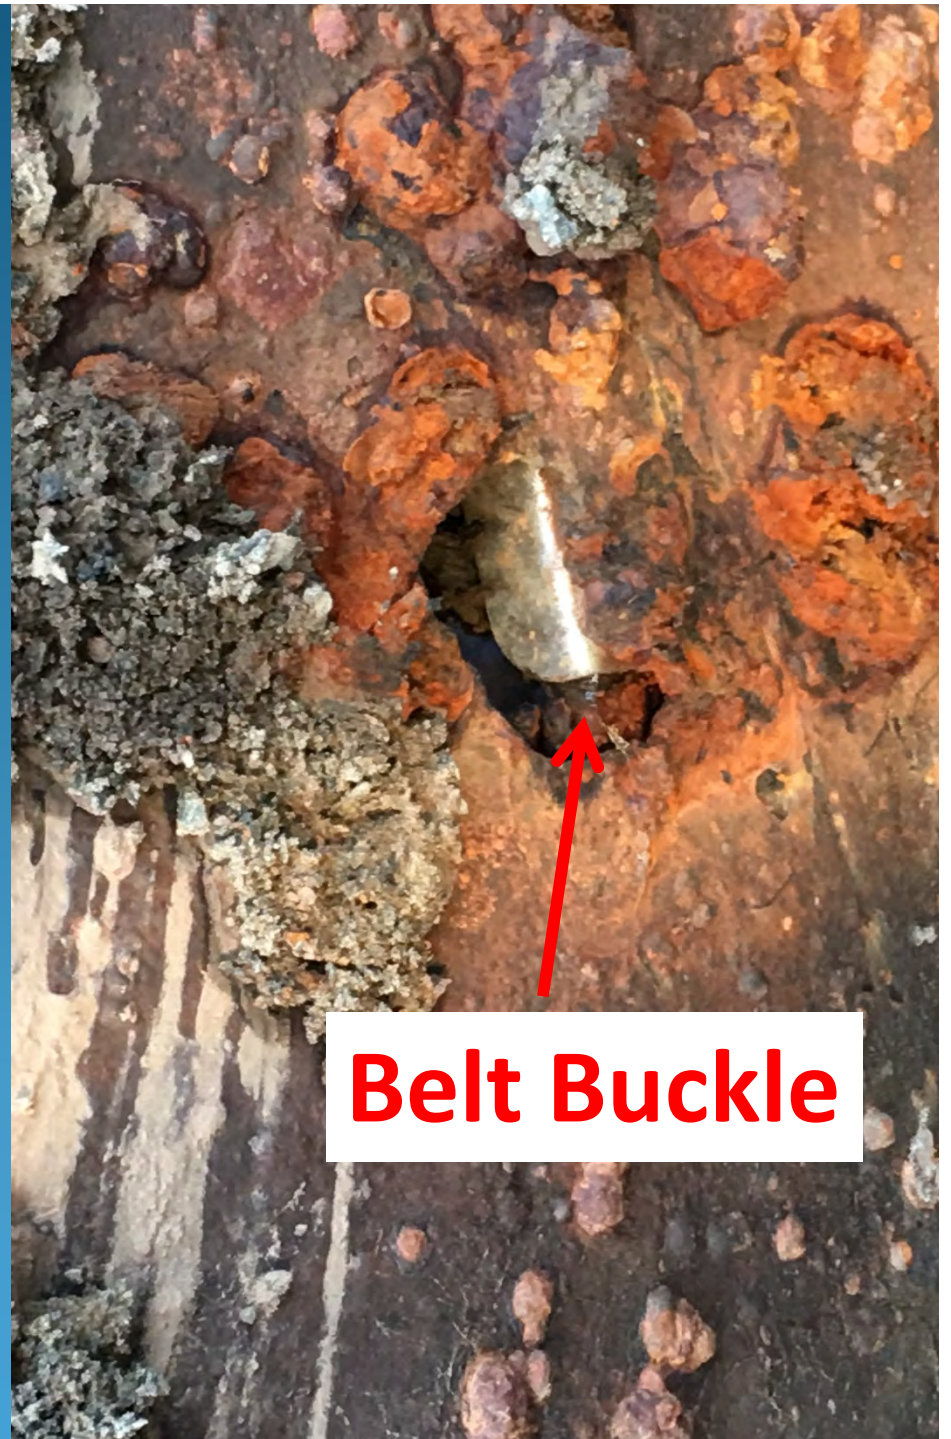
Pipe Leak

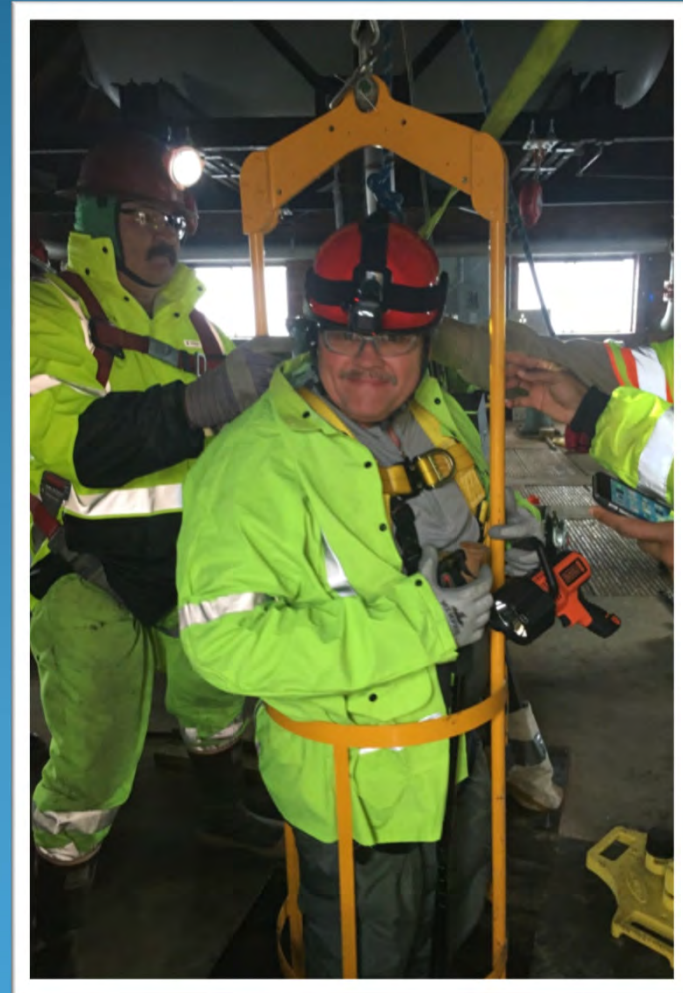
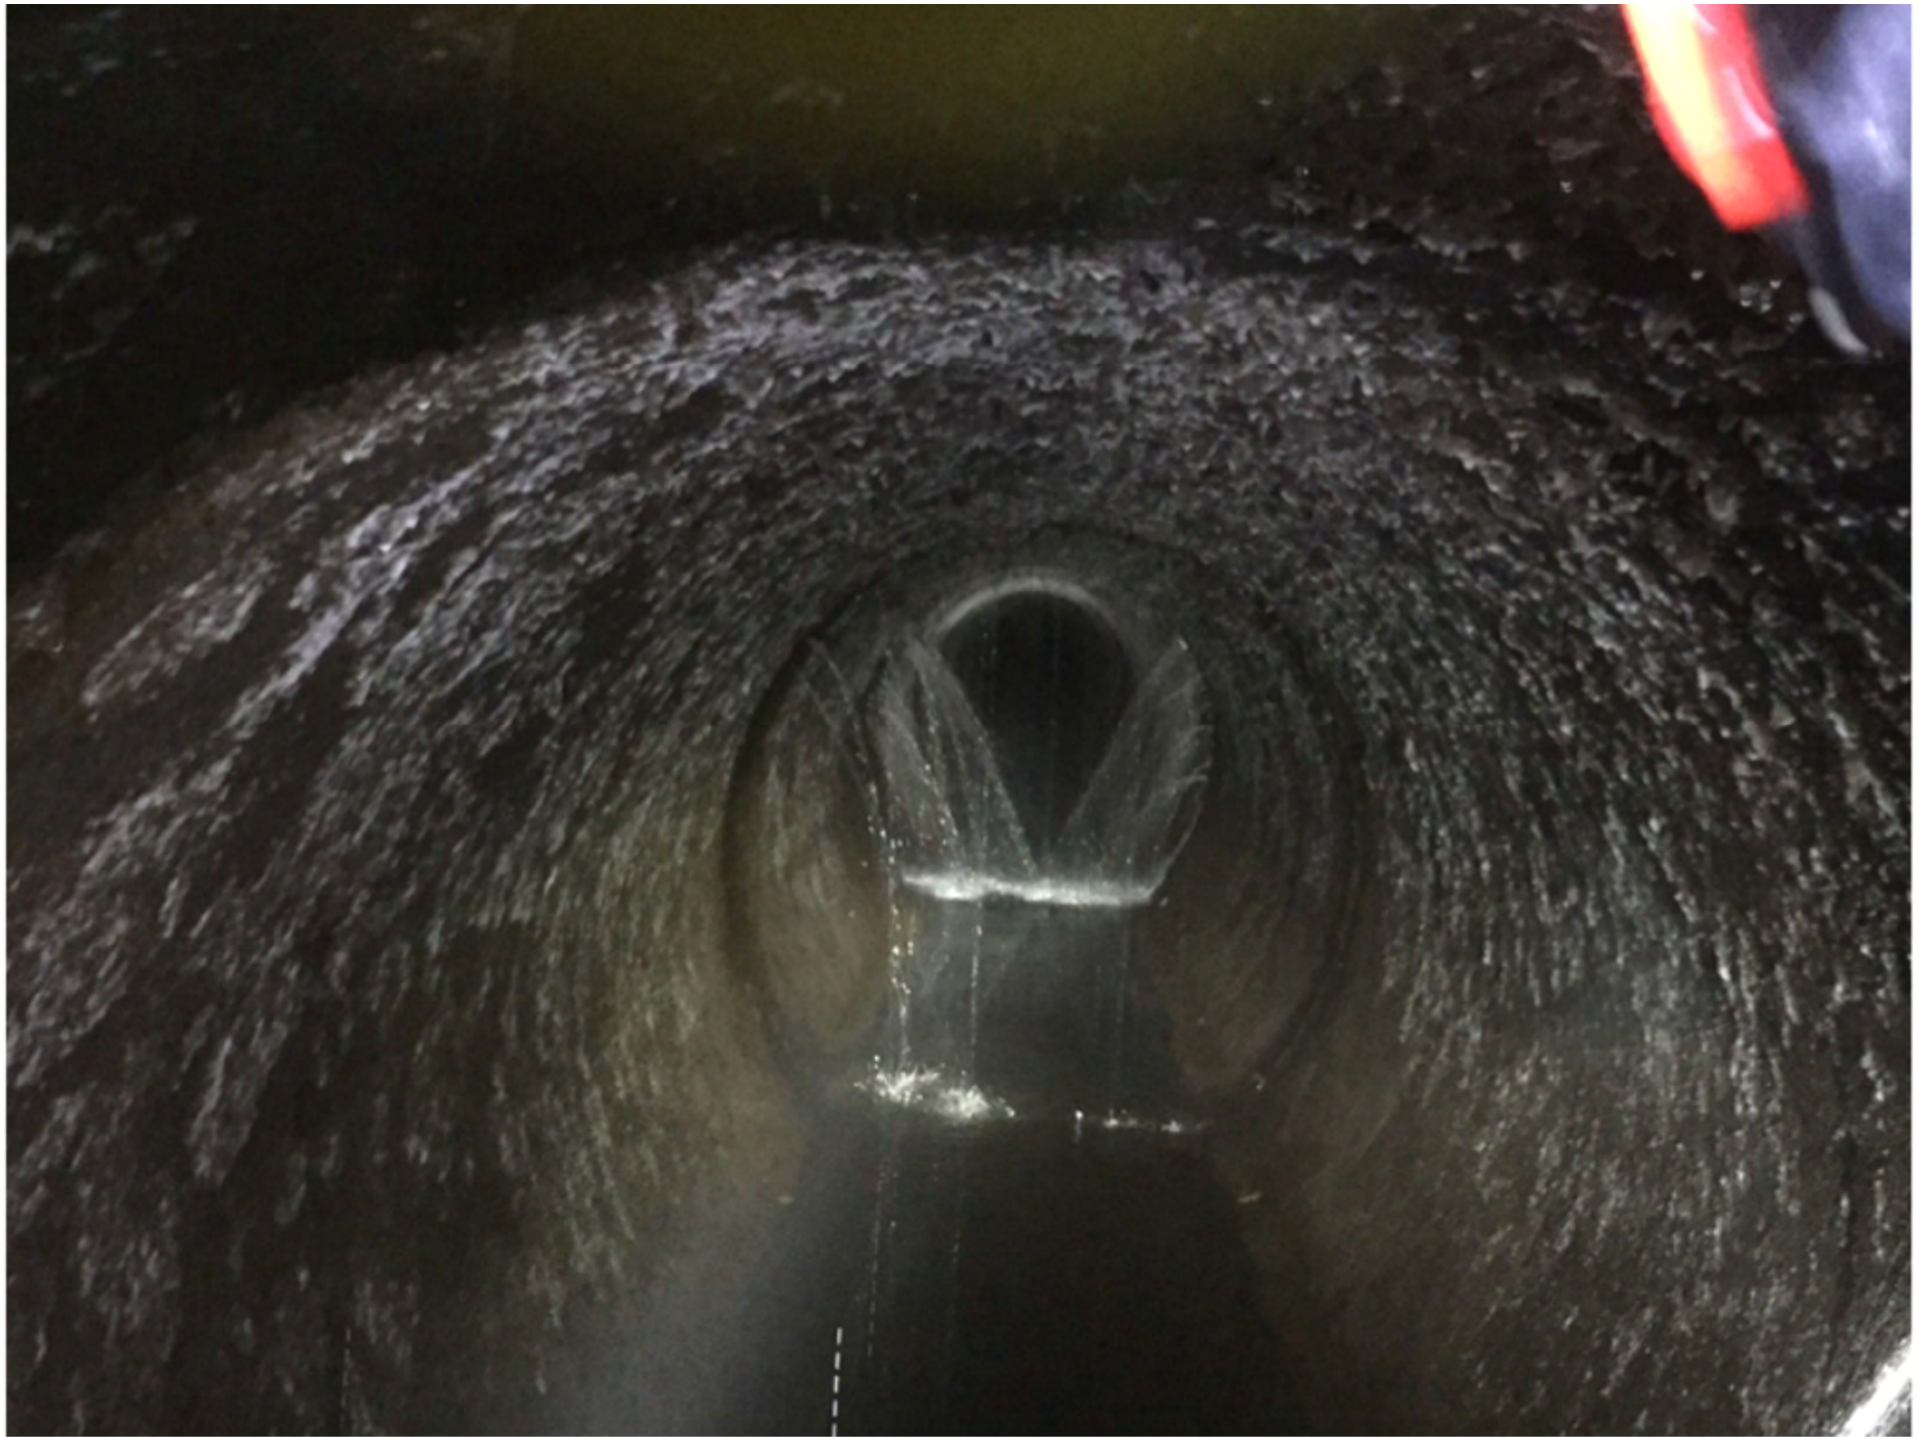
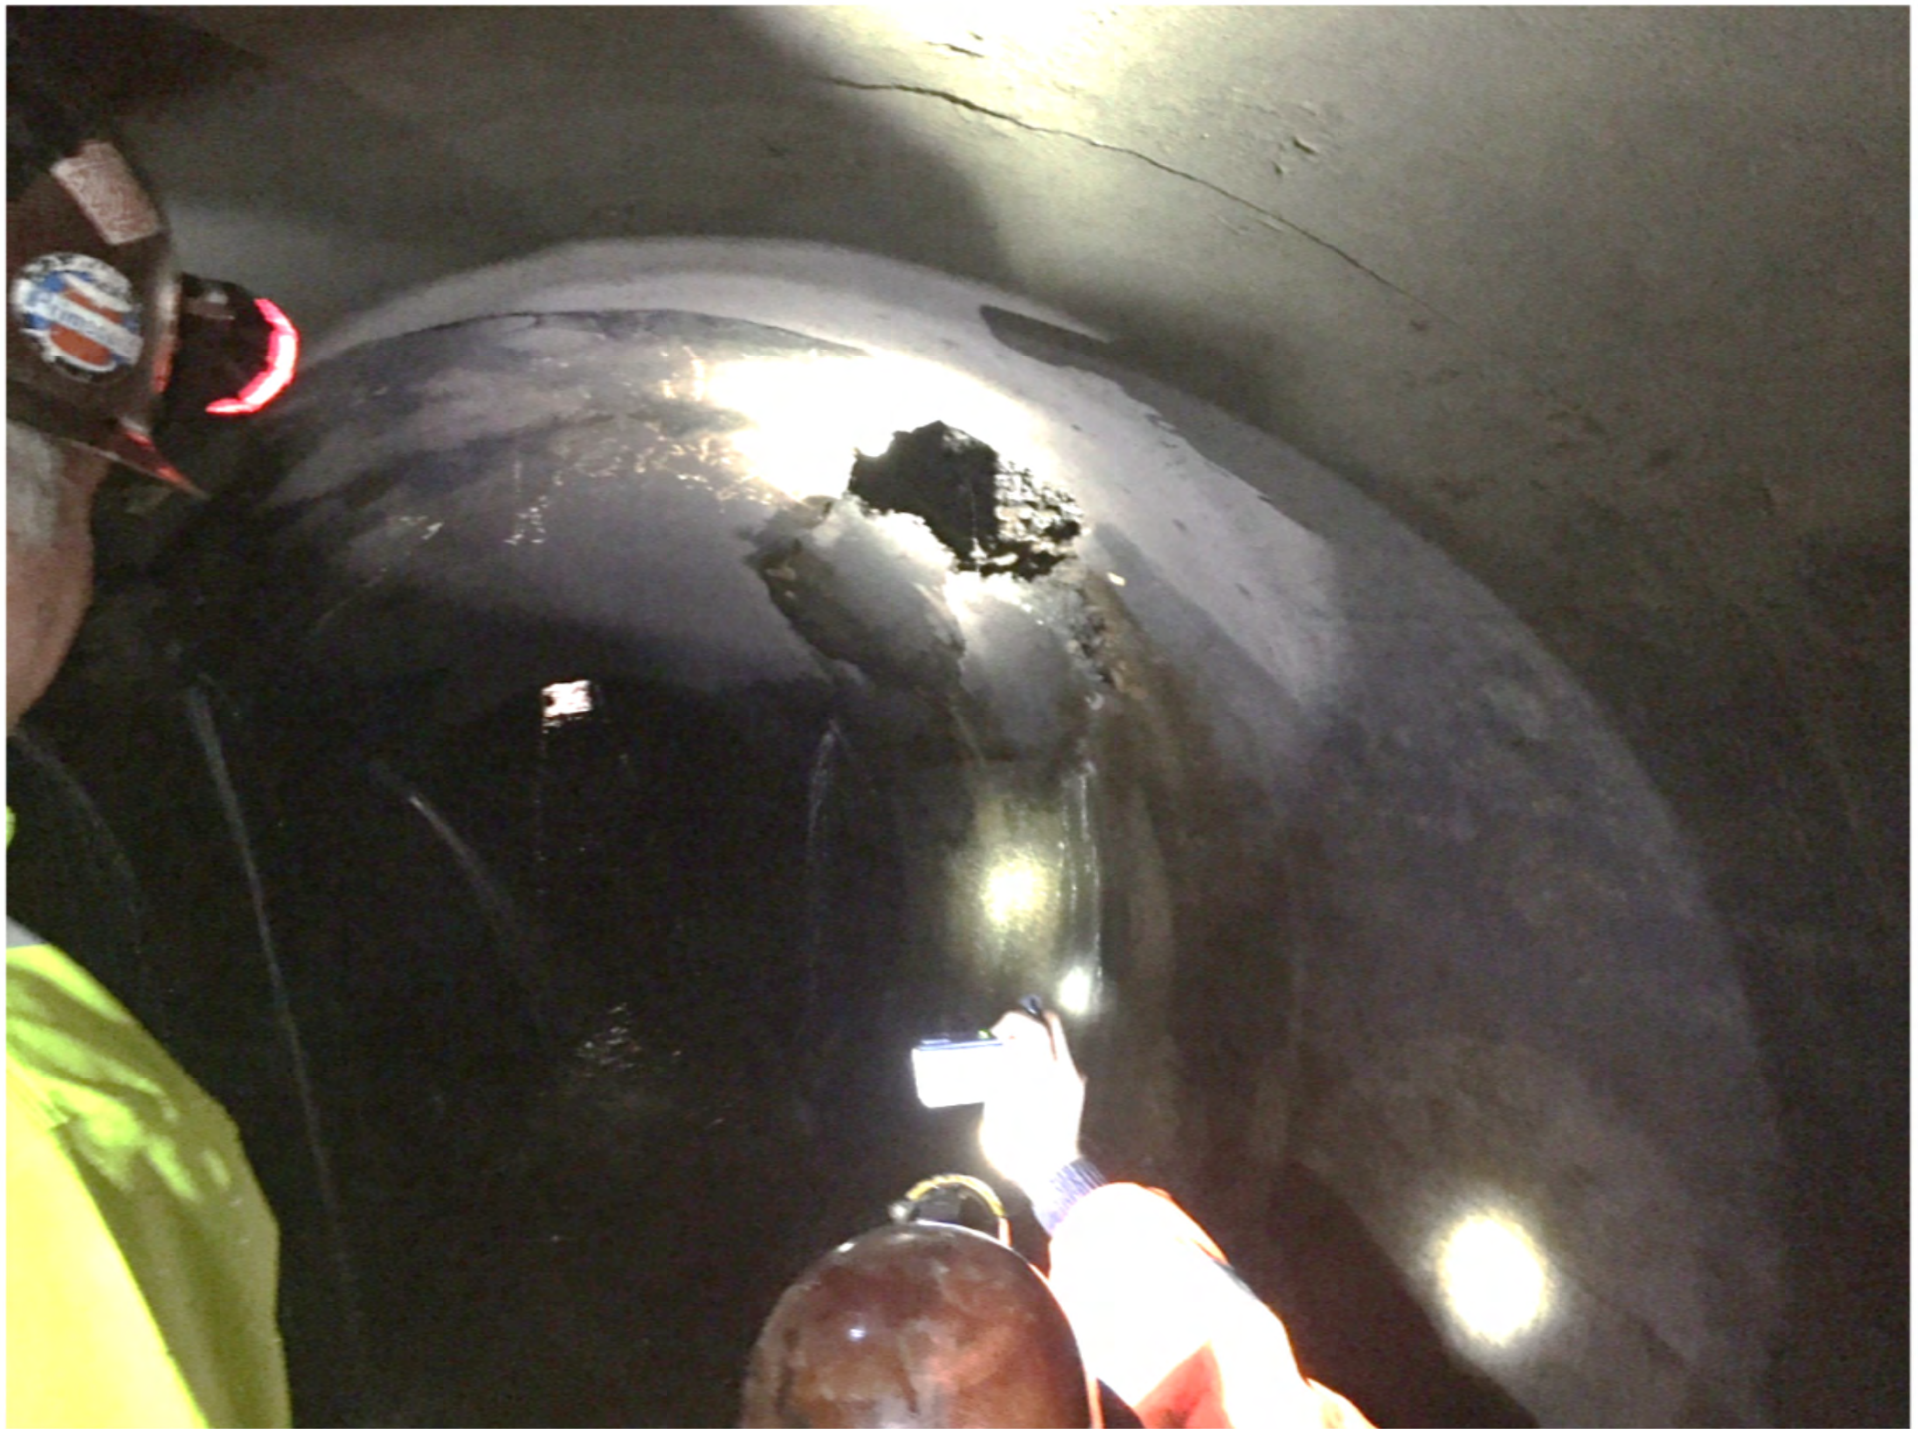
Initial Tunnel Inspection

- Initial entry through reservoir intake
- Team of RWA, contractor and rescue team walked entire length of tunnel
- Sandstone/Trap rock
- Condition of tunnel generally good
