# Proper Planning & Analysis Results in a Focused, Cost Effective Pipeline Rehab Project

**Andrew Costa**

Aegion Corporation

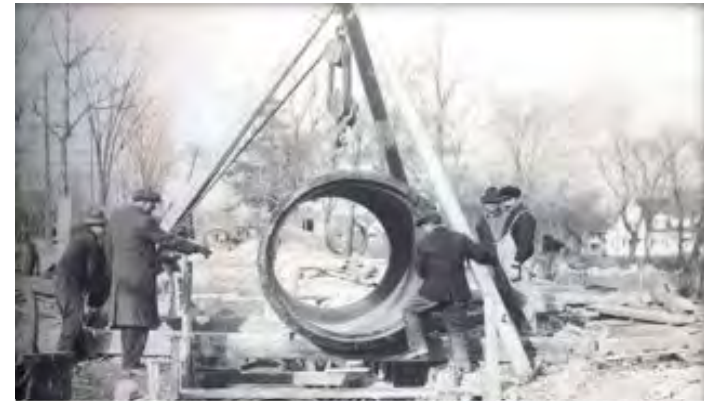
**Original Pipe Installation**

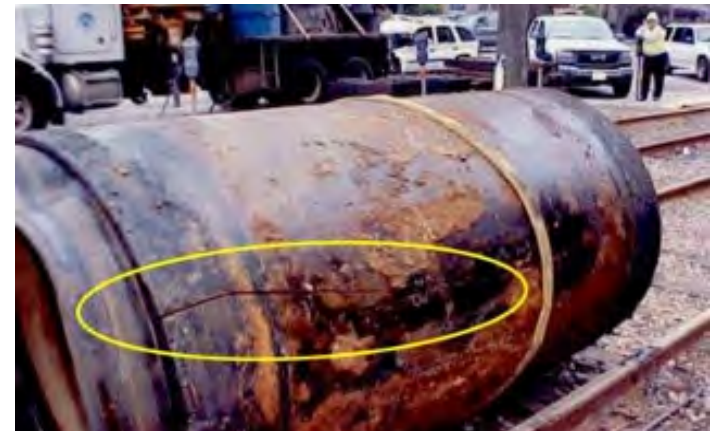
**2006 Excavated Repairs**

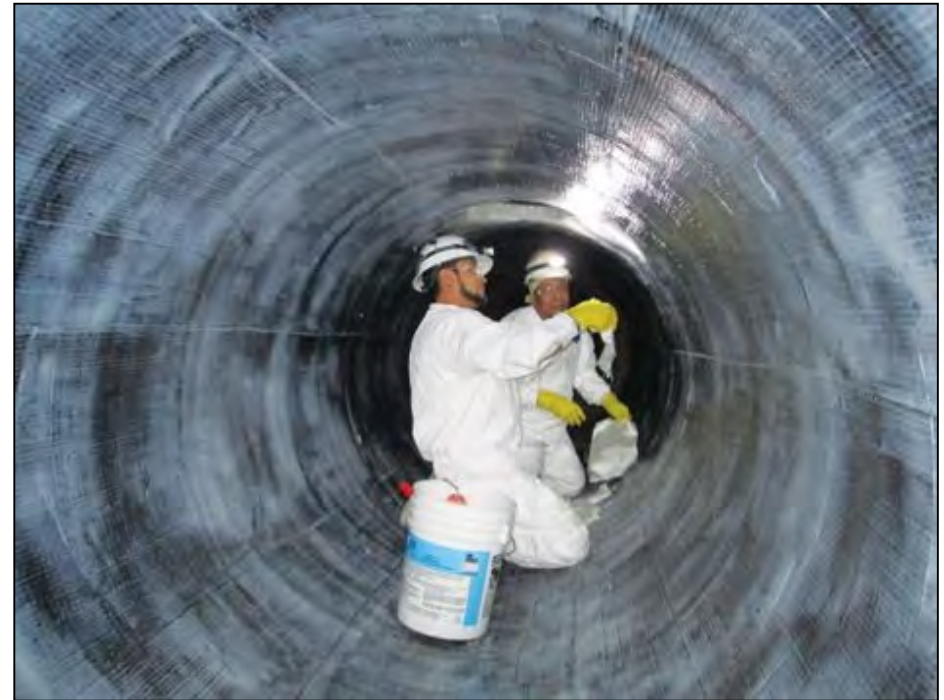
**Nominal Thickness  
of 0.26”**

**~1/2” Cross-sectional ID Loss**

1. GFRP for steel
2. Hoop CFRP
3. Long CFRP
4. GFRP for watertightness
5. Hoop CFRP
