# Sectional CIPP of Sanitary Sewer Force Main Preserves Historic Hull Waterfront

Charles Tripp, P.E. Project Manager

November 16, 2017

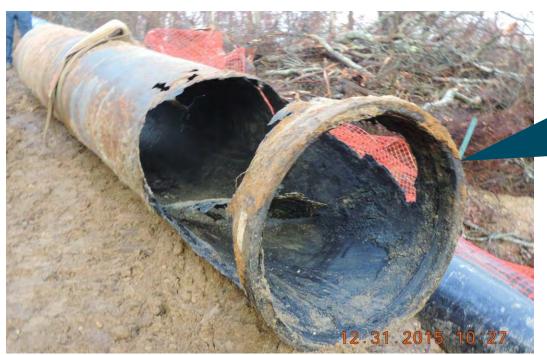
30" steel pipe deteriorated due to H<sub>2</sub>S corrosion resulting from low buildout and low flow velocity.

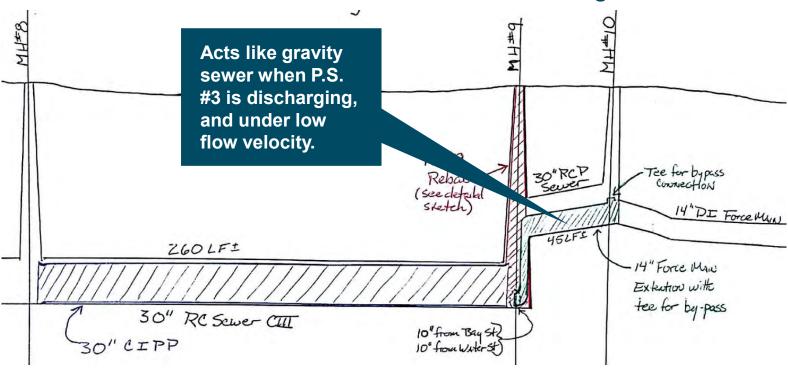
- Investigation
  - In 2002, Town extends 14" DI forced main 45 LF down existing 30" RCP sewer and abandons existing valve manhole
  - CIPP line downstream sewer, and line discharge manhole

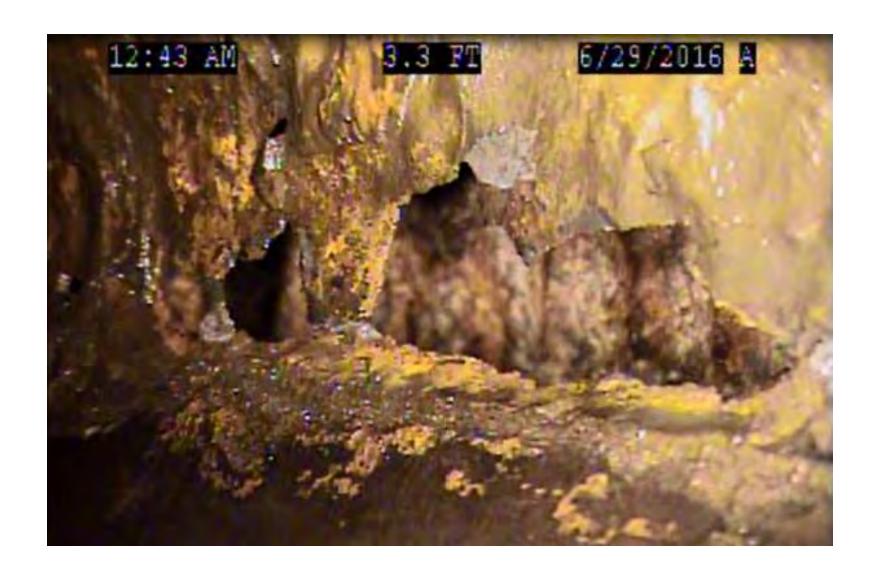
- Investigation
  - In June 2016, Town CCTV inspects 14" DI force main from discharge manhole over length of 45 LF extension
  - C Downstream-most 15 LF are found to be deteriorated from H<sub>2</sub>S corrosion

- Sectional CIPP Repair
  - Repair 15 LF from downstream manhole location using Sectional CIPP repair
  - C Replace DI drop leg with 15" PVC

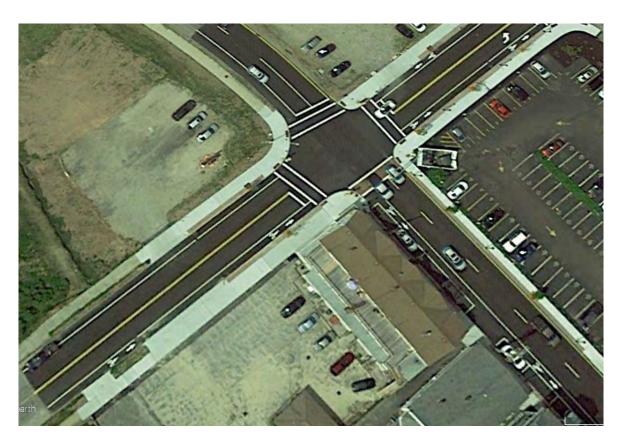
- Newly Paved Intersection at Bay Street
  - Under MassDOT moratorium

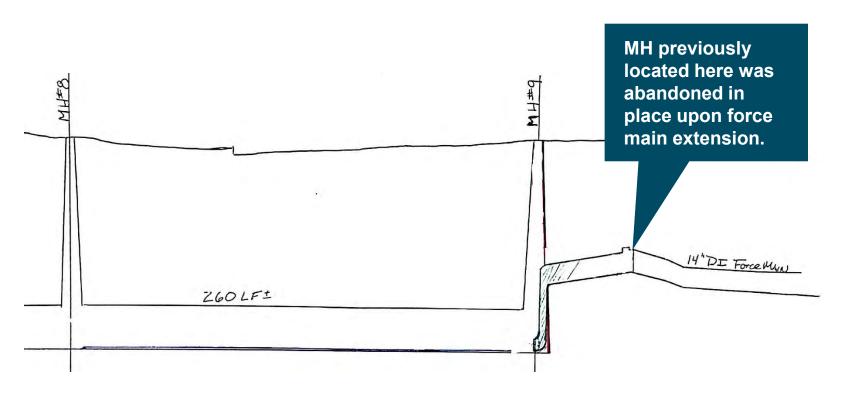
Only discharge manhole at Bay Street intersection is available for access to complete work
