NASTT-NE's 2018 Regional Trenchless Conference

IMPLEMENTING ACTION ITEMS DEVELOPED FROM EVALUATING 200,000 LINEAR FEET OF LARGE-DIAMETER SEWER MULTI-SENSOR INSPECTIONS IN THE CITY OF HARTFORD

JASON WATERBURY PE, THE METROPOLITAN DISTRICT
VINTA VARGHESE PE, JACOBS, WETHERSFIELD, CT
JOHN OSOSKIE PE, JACOBS, WETHERSFIELD, CT

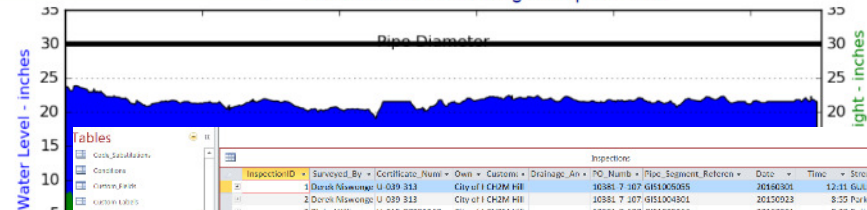
Sediment and Water Height Graph: 0 - 276'

Sonar Inspection Report

| Average Water Level(in.): | 22 |
| sediment Volume(Cubic yards): | 11.4 |
| As-is Capacity / As-built Capacity (%): | 77.3 |
| Average Cross-Sectional Restriction(sq in.): | 160.8 |
| Max Cross-Sectional Restriction: | 38.0% at 251.1' |
| Average Height of Sediment: | 11.1" |
| Max Depth of Sediment: | 14.9" at 221.5' |

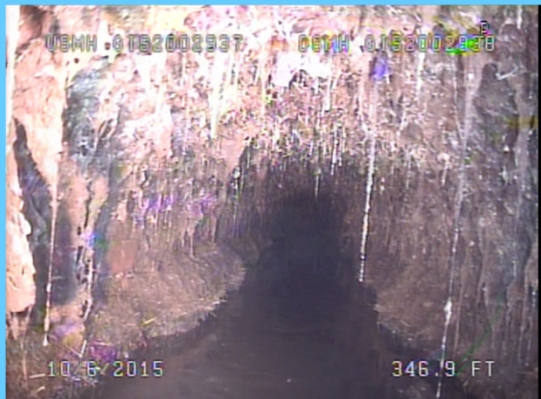
Pipe prior to cleaning with roots

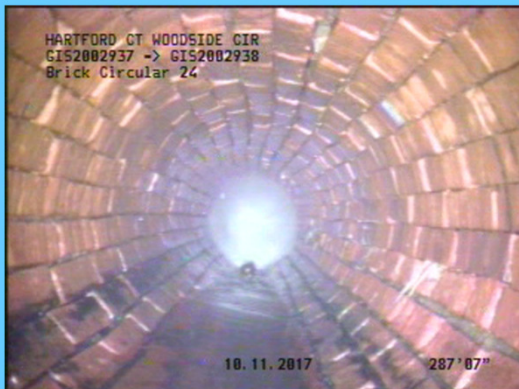
Pipe after cleaning and root removal

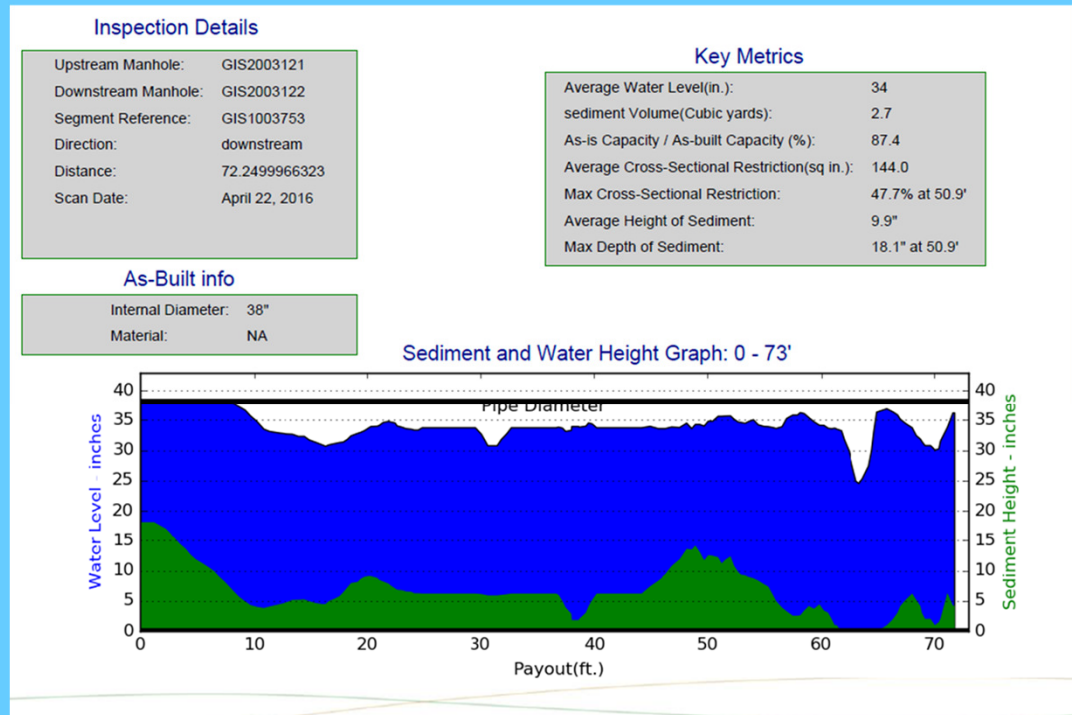
Sediment level in pipe – SONAR inspection
