Using SL-RAT to Reduce SSOs

Daniel R. Murphy, P.E.
Lindsey L. Donbavand

November 17, 2016

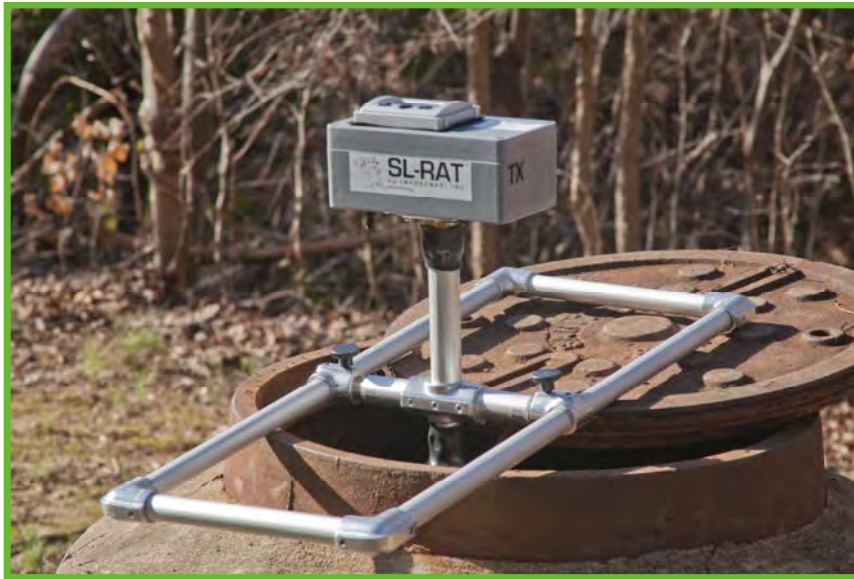
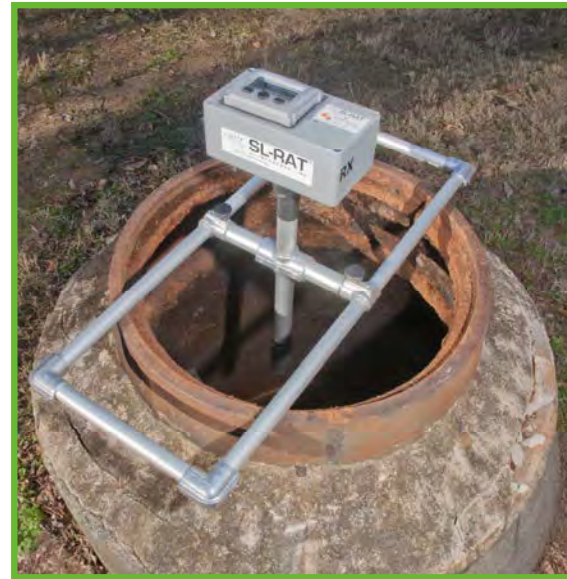
- Place RX and TX units over a manhole

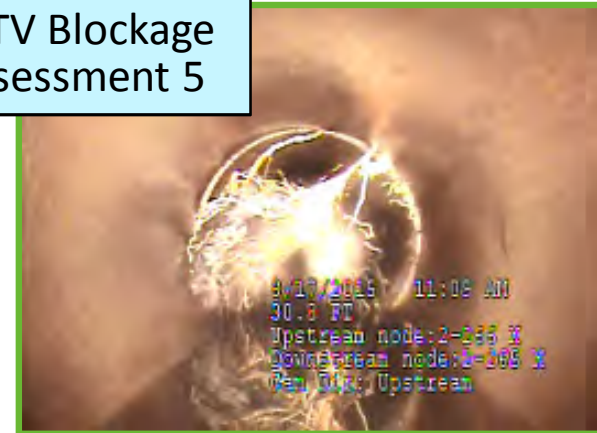
CCTV Blockage
Assessment 5

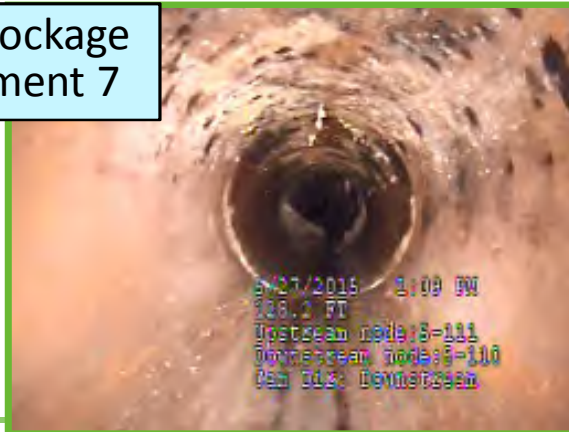
CCTV Blockage
Assessment 7

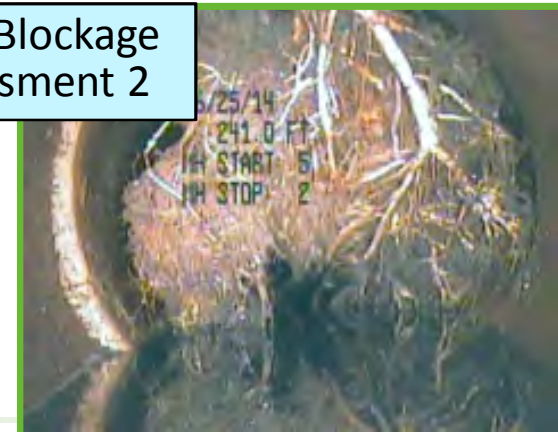
CCTV Blockage
Assessment 2

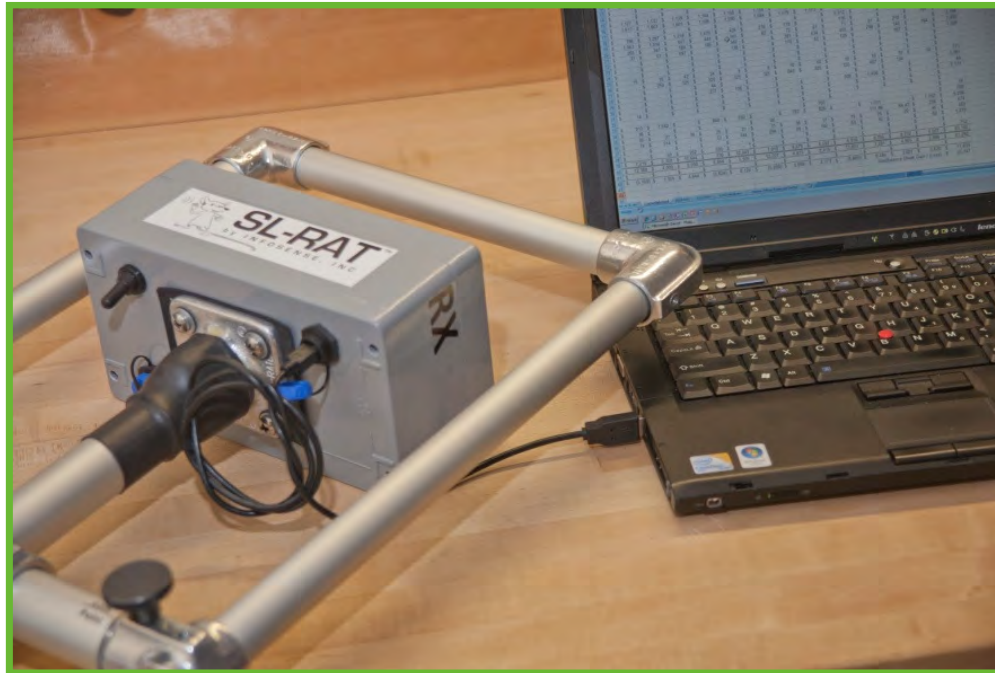
Downloading Data

- Connect SL-RAT to a PC using the USB connection
- Outputs CSV file

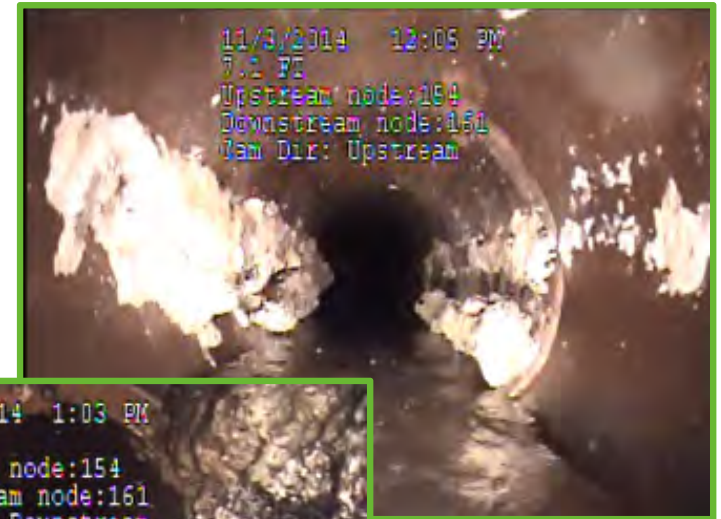
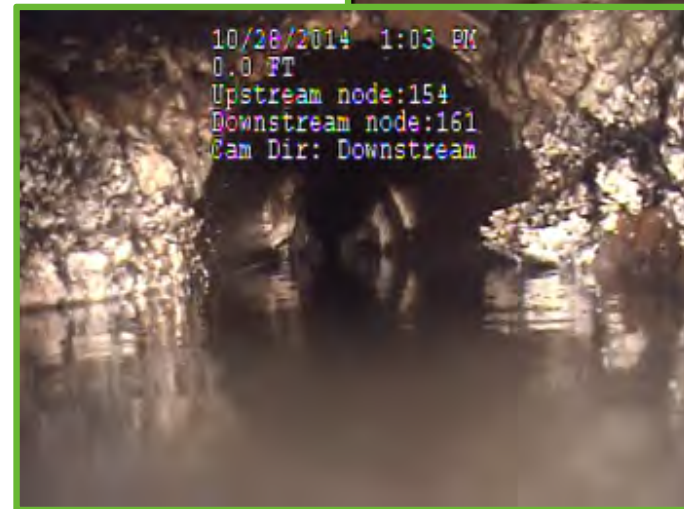
Partially Removed Grease Buildup

- MH 11-154 to MH 11-161
- Pre-cleaning score = 0
- Post-cleaning score = 4
- Grease buildup – Score improved but buildup still exists

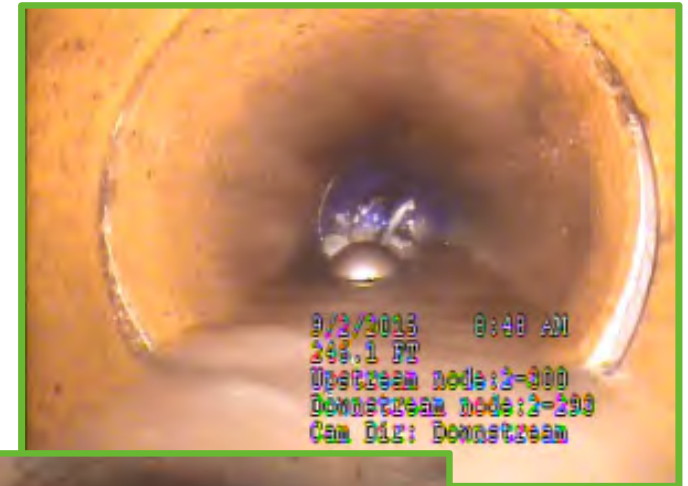
Sag in pipe

- MH 2-300 to MH 2-293
- Pre-cleaning score = 2
- Post-cleaning score = 4
- Sag – Score will not improve until pipe fixed

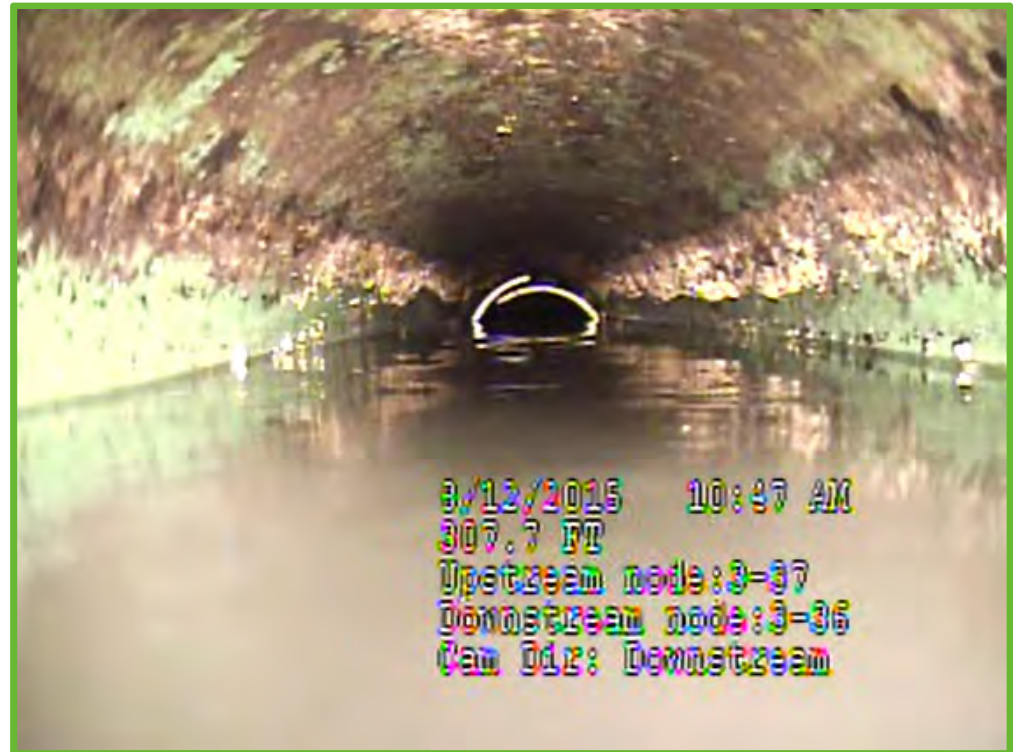
Collapsing Pipe and Sag

- MH 3-37 to MH 3-36
- Pre-cleaning score = 3
- Post-cleaning score = 1
- Pipe collapsing and sag – condition deteriorating

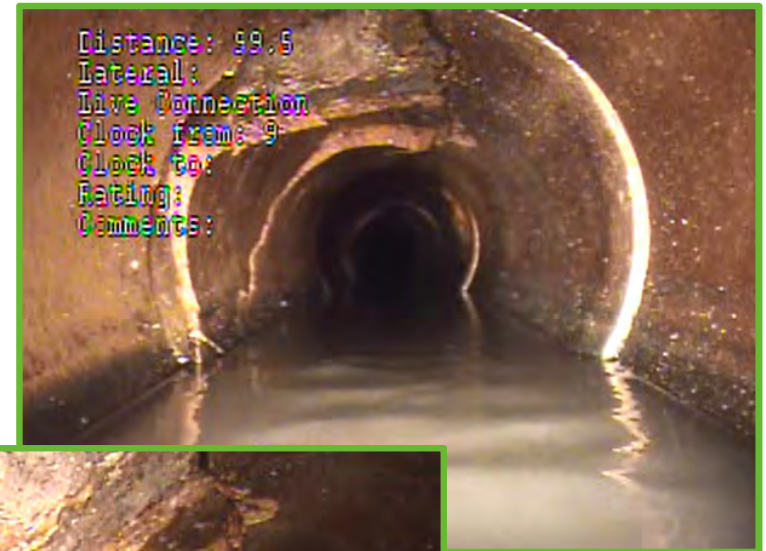
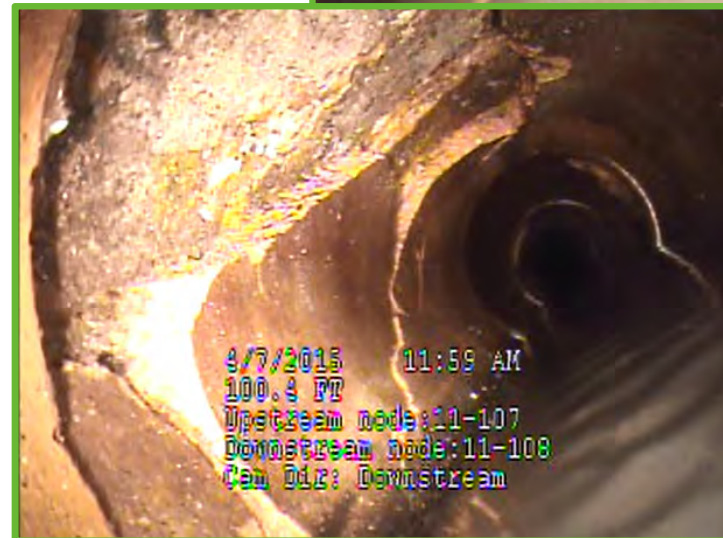
Pipe Section Missing

- MH 11-107 to MH 11-108
- Pre-cleaning score = 2
- Post-cleaning score = 2
- Pipe section missing
