# ***NORTHEAST JOURNAL***

OF TRENCHLESS TECHNOLOGY PRACTICES

***“Celebrating Trenchless”***  
***4th Annual Northeast Regional Chapter***  
***Trenchless Technology Conference***  
***Syracuse, New York***

**2019 FALL EDITION**

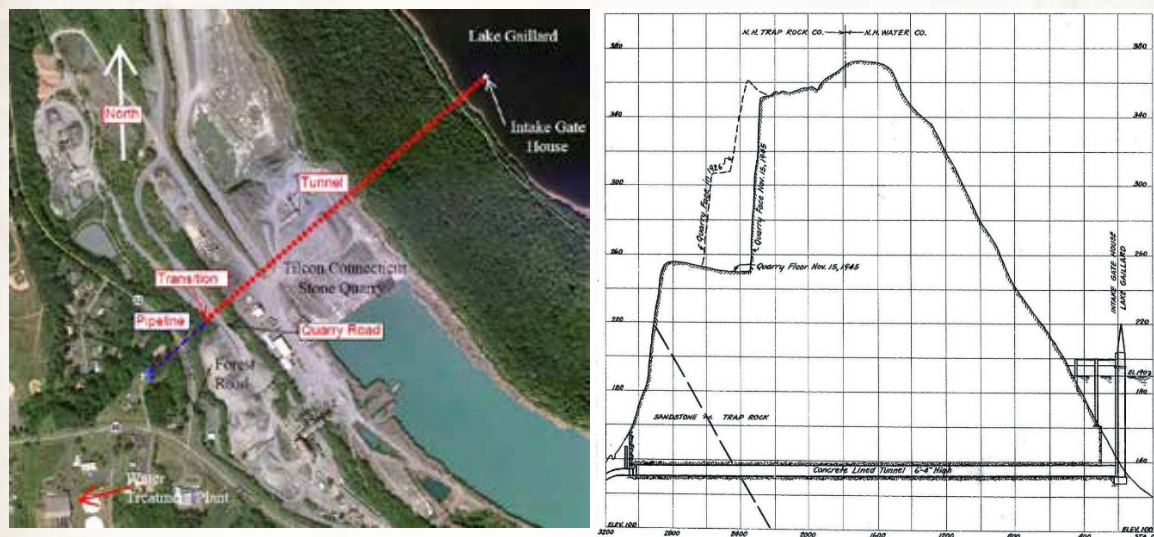
Figure 1. Plan and profile of the Great Hill Tunnel.

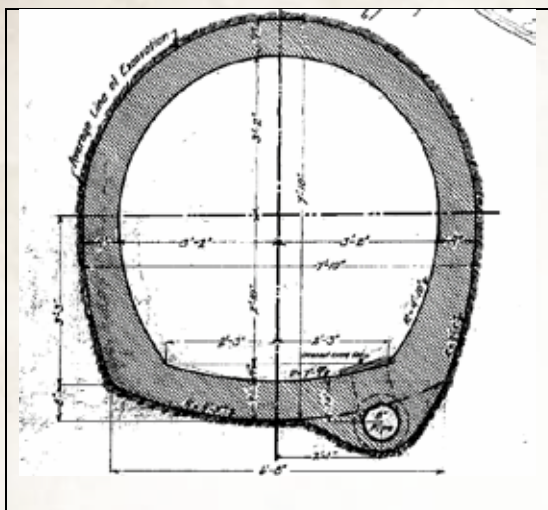
Figure 2. Cross Section of Tunnel

The tunnel was excavated through the trap rock and sandstone in a 7 foot 10 inch wide by 7 foot 10 inch high horseshoe shape, as seen in Figure 2. As shown in the figure, there is a minimum 9-inch-thick plain concrete final lining that results in finished inside dimensions of 6 foot 4 inches wide by 6 foot 4 inches high. Based on geologic mapping, the GHT penetrates the Holyoke Basalt (trap rock) from the Intake Gate House to approximately Sta. 24+30, and the underlying Shuttle Meadow Formation (sandstone) west of Sta. 24+30.

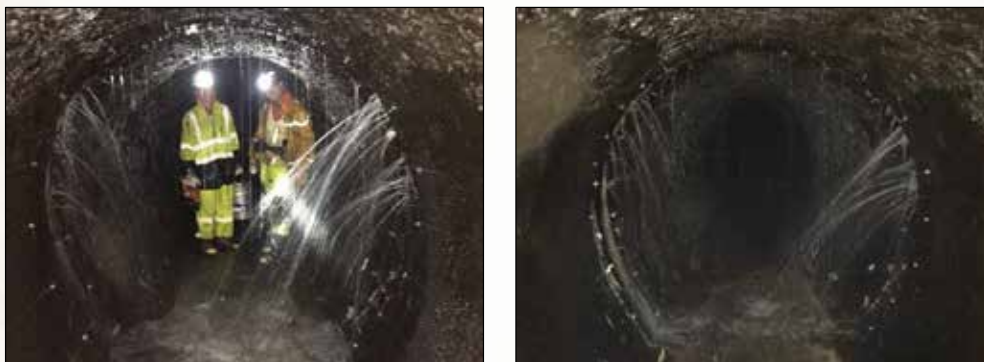
Figure 3. Before and after chemical grouting on the left arch.

Another recommendation resulting from the initial inspection was for the heavy seepage at the construction joints in the first 71 feet of the tunnel to be injected with chemical grout. At each joint, the injections were supposed to chase the seepage around the joint and then seal them off. This was attempted with limited success and was not considered critical for the operation of the tunnel (Figure 3). Because this was not deemed critical to the continued operation of the tunnel, no other methods for sealing the joints were considered.

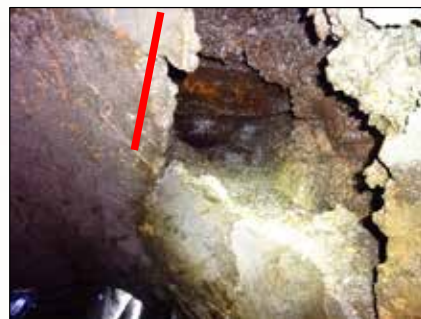
(d) Looking into void (downstream), approximately 10 feet deep.

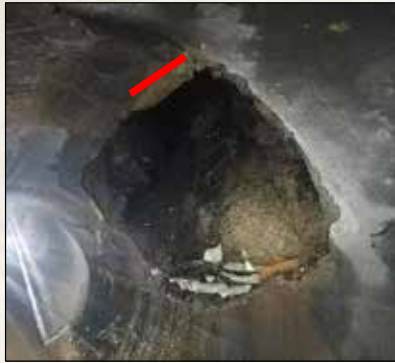
(e) Defect after sawcutting and chipping in preparation for repair.

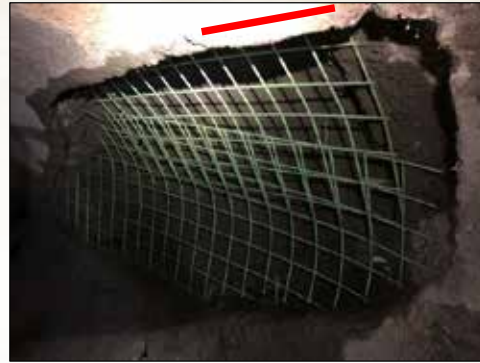
(f) Welded wire mesh in place during shotcrete repair.

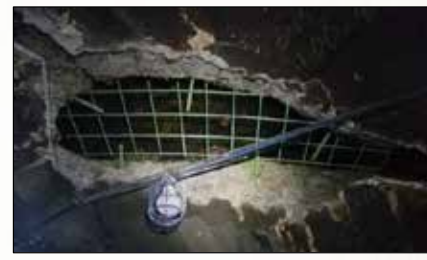
(c) Welded wire mesh in place for shotcrete repair.

Figure 5. Views of defect in crown at Sta. 23+15 from various inspections.

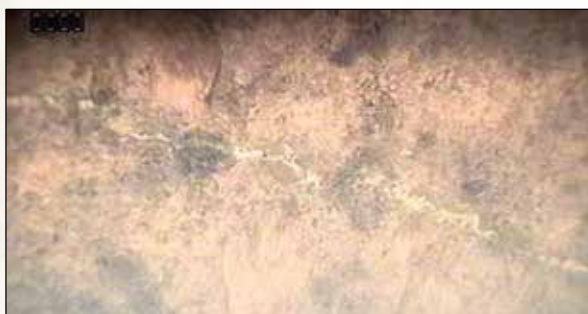
(a) Defect during 2011 ROV Inspection (SeaView, 2011).

Figure 6. Views of defect in tunnel sidewall at Sta. 6+90 from various inspections.

Finally, Figure 6 shows images from the 2011 ROV inspection and the manned inspection of a surficial crack at Sta. 6+90. With good visibility, the defect was fully visualized with the ROV. However, during the 2017 planned ROV inspection, the defect could not be found because of the poor visibility.

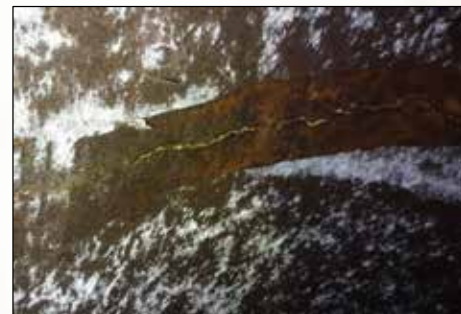
(b) Defect after dewatering.

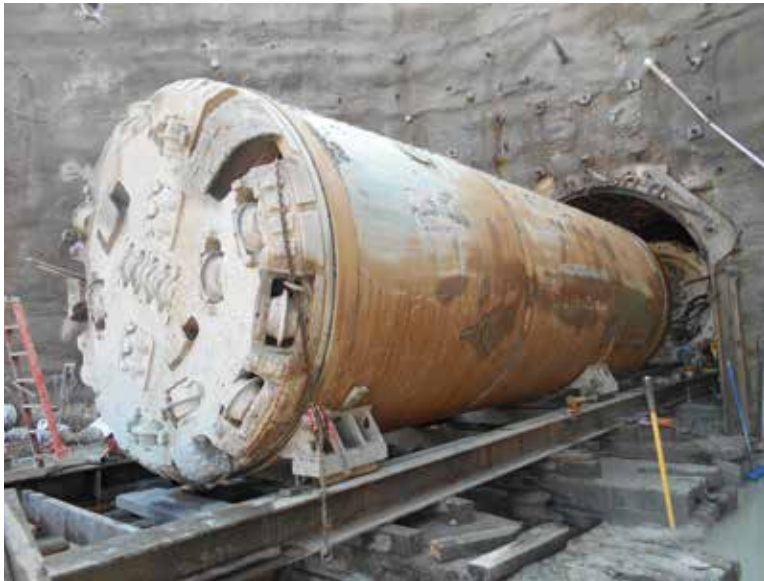
Figure 3: MTBM pushed through Valve Chamber portal to complete the land leg tunnel

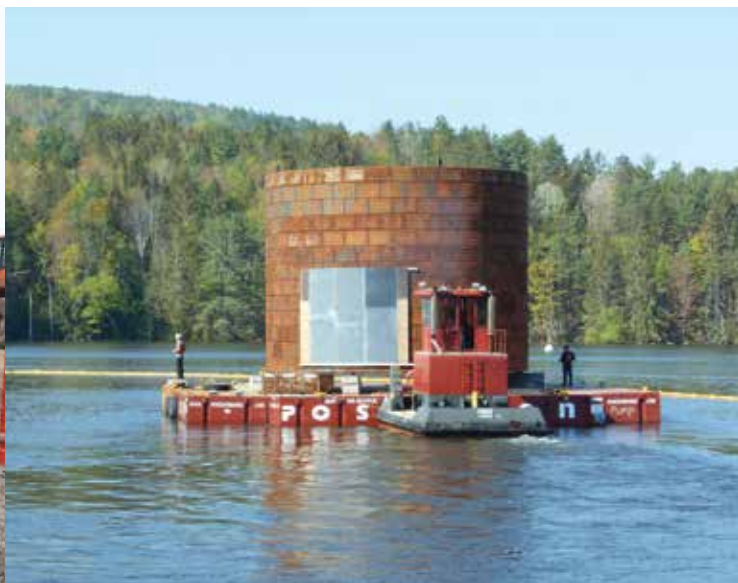
Figure 5: Water leg cofferdam structure with fiberglass soft eye

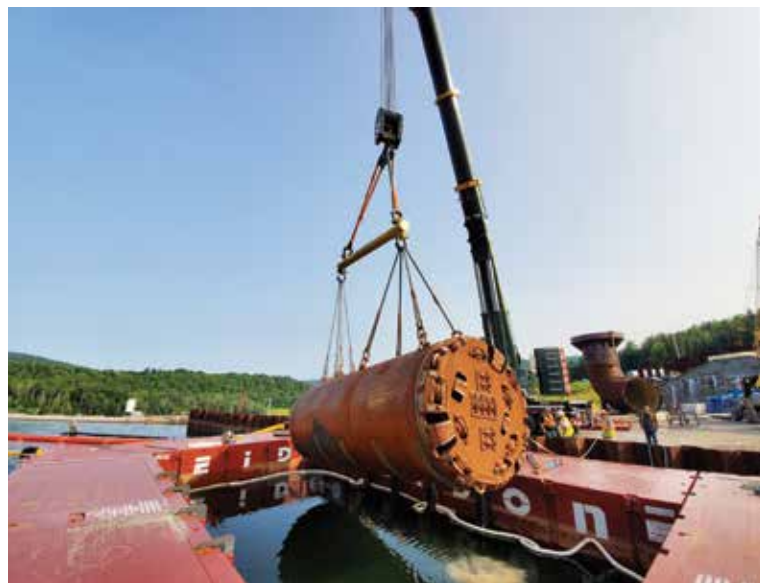
Figure 6: The MTBM unit was retrieved from a depth of approximately 153 feet on July 10, 2019

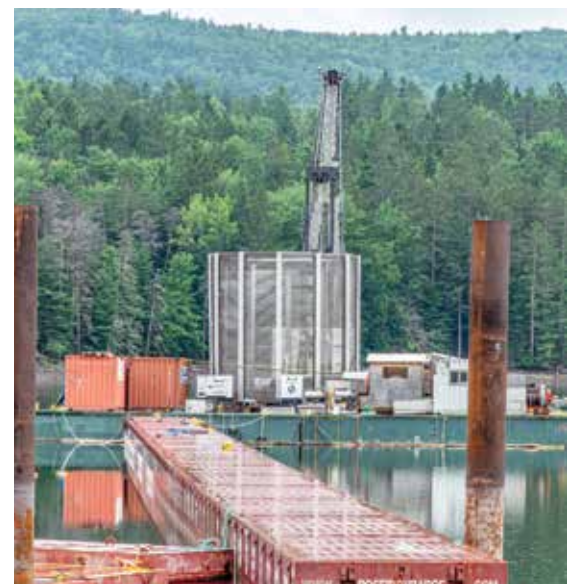
Figure 9: The stainless steel Intake Structure was lowered into place and tremie concreted

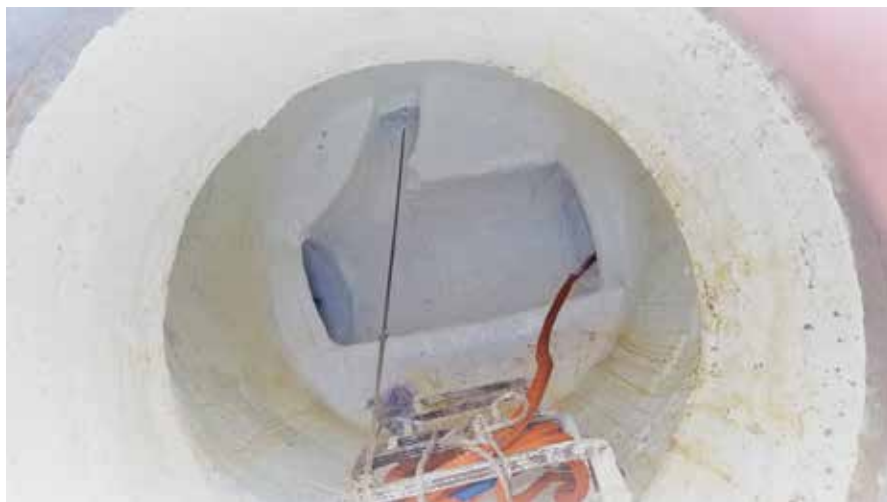
*The 39 manholes along the 1.8 mile segment were coated with an aquatic-safe epoxy*

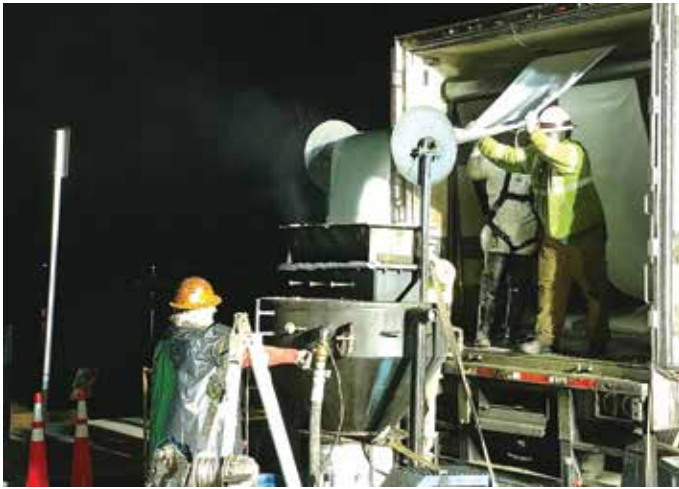
*To reduce traffic disruption in downtown Wareham, CIPP liner was installed at night*

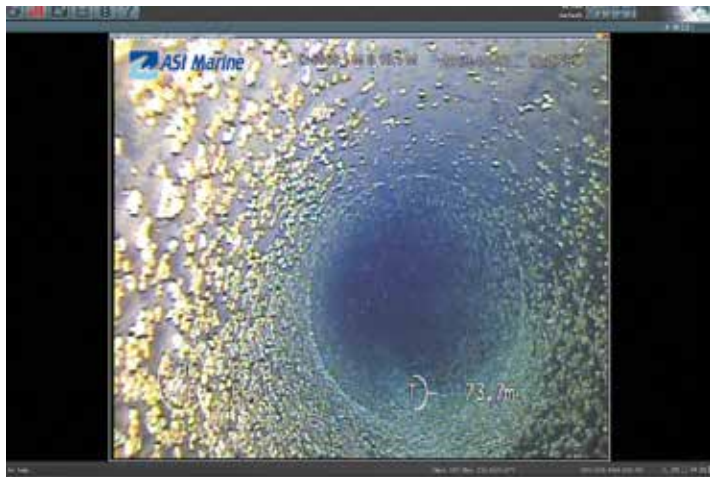
Figure 1. ROV pictures showing quagga mussel build up prior to pigging

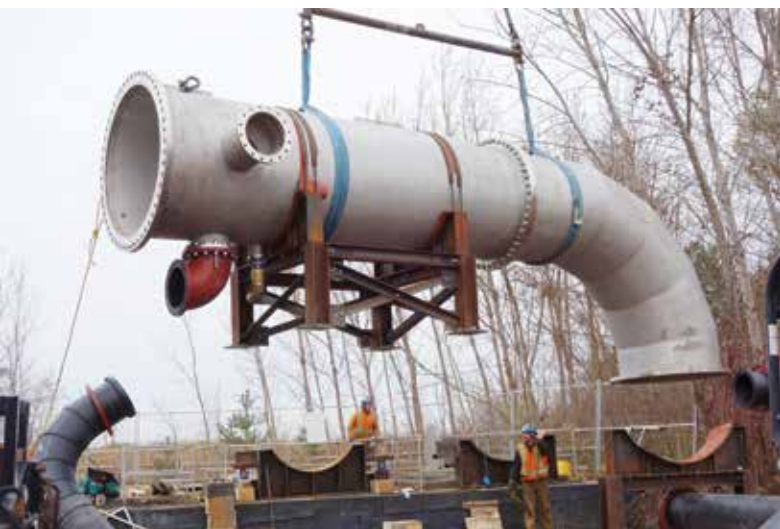
*Figure 2.60-inch launcher being moved from one intake to another*

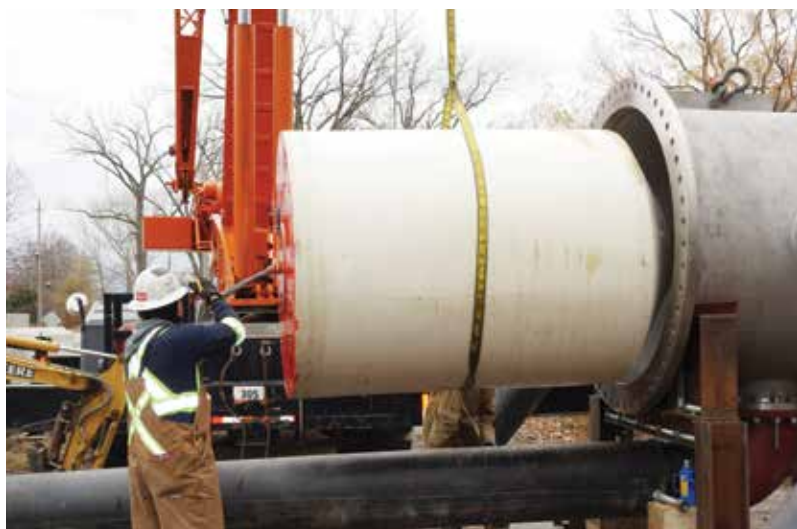
*Figure 3.60-inch durafoam style pig being placed in launcher*

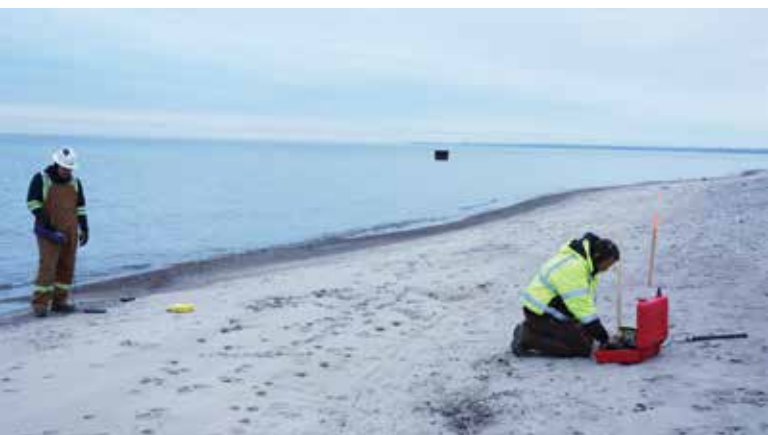
Figure 4. Each pig is tracked as it leaves the shoreline

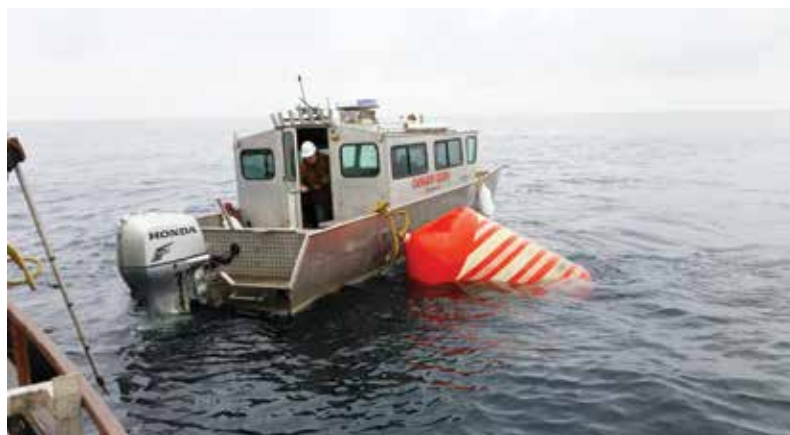
Figure 5. 60-inch brush pig being readied for tow back to shore

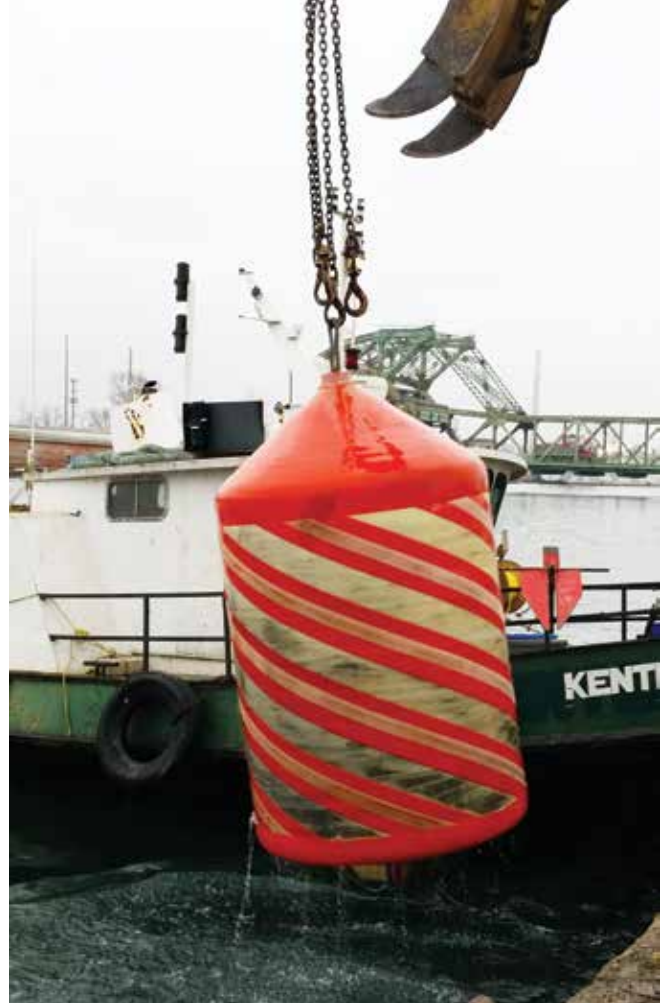
Figure 6.60-inch brush pig after being towed to shore

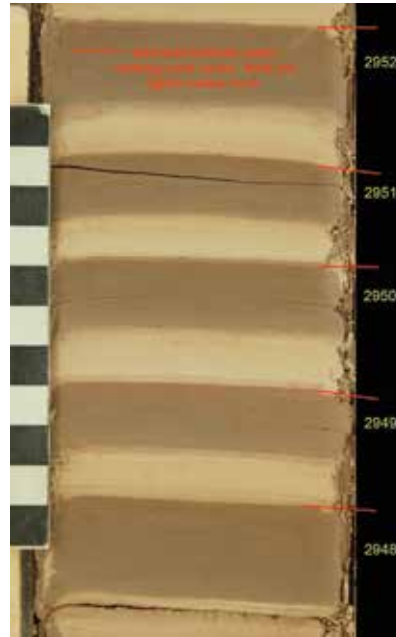
*Figure 2- Varves of the former Glacial Lake Hitchcock, retrieved from Glastonbury, CT as part of the North American Glacial Varve Chronology project (John Ridge, Director). Bar scale on left is in centimeters. Red lines indicate start of varve-year “summer” deposits and also the sand layers described in text.*

Of interest to microtunneling design and MTBM performance in the Hartford Basin, the very soft and deep varved sediments found in the vicinity of the city and close-in suburbs appear interbedded with sands that allowed water to flow laterally between the less-permeable layers of clay, indicative of the strong horizontal anisotropy of the deposits (see Figure 2). Rather than a perceived “uniform” deposit of lean clay, the varved glacial sediments behaved as a stack of alternating thin sand layers with interbedded clay horizons.

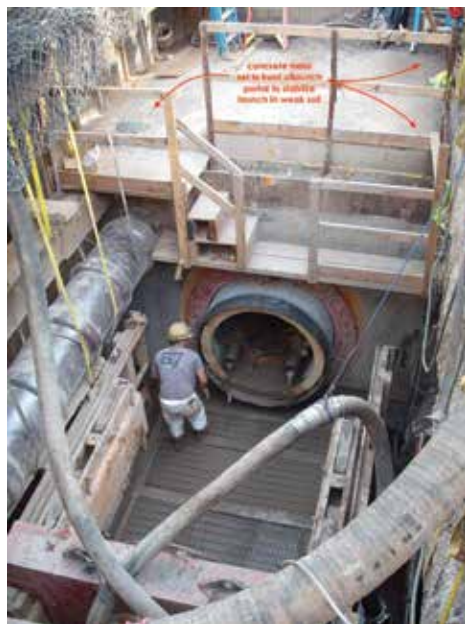
**Figure 3-** Photograph of MTBM launching shaft depicting the use of concrete mass ground stabilization in front of launch portal to stabilize weak soils.

In response to these ground effects and challenges, one specialty contractor opted to install a large mass of low strength concrete in front of the jacking shaft launch portal to stabilize the launch of the 48-inch MTBM out from the shaft and into the soft ground ahead of the drive (see Figure 3).

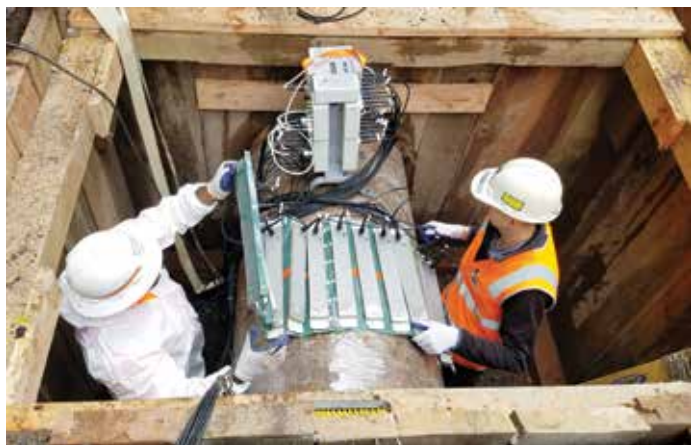
External NDT inspection of exposed CI pipe

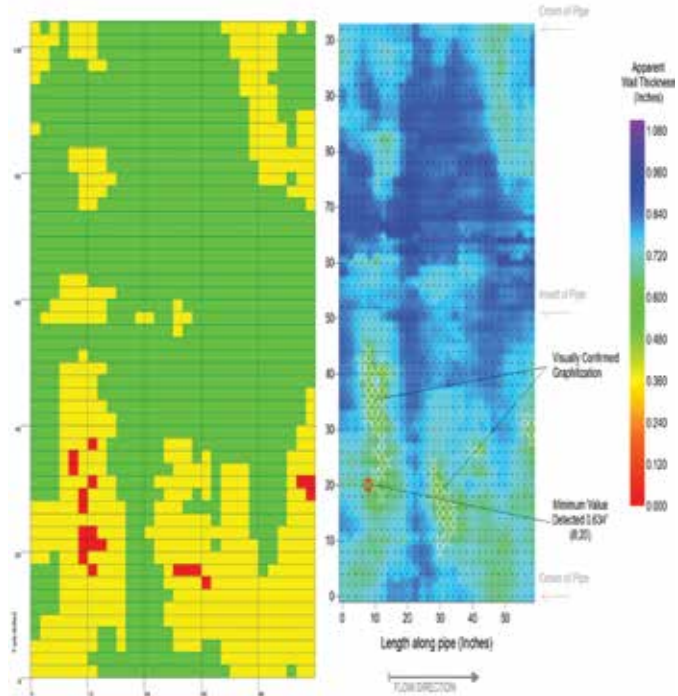
*Real time display and color-coded topographical image showing graphitization*

graphitization was discovered. Subsequent post-processing of that data indicated that the wall thickness was actually 0.630 inches in that location compared with an original pipe wall thickness of 0.920 inches.

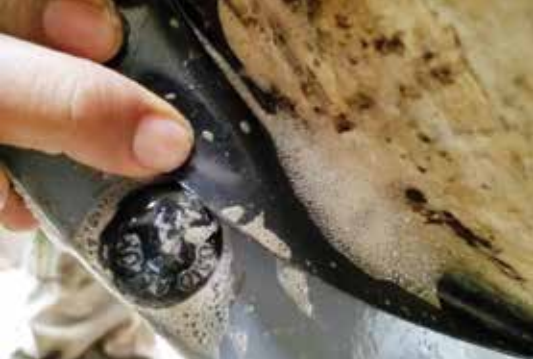
Leak at CI coupling

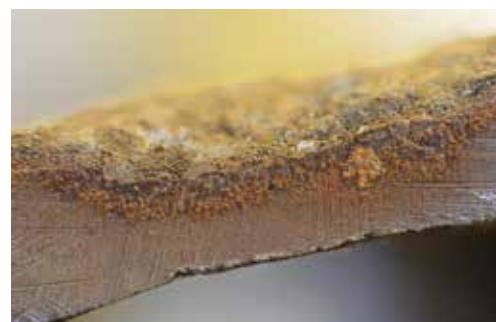
Graphitization cross section
