# Sectional CIPP of Sanitary Sewer Force Main Preserves Historic Hull Waterfront

Charles Tripp, P.E. Project Manager

November 16, 2017

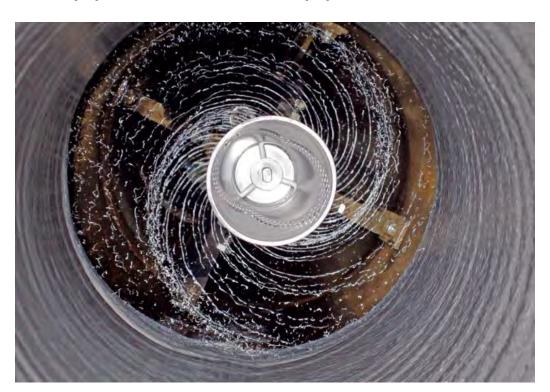
- Spin-Cast Pipe Lining Repair
  - Was not believed to be viable, as it would be tough to seal voids between DI pipe and RCP host pipe outside of DI

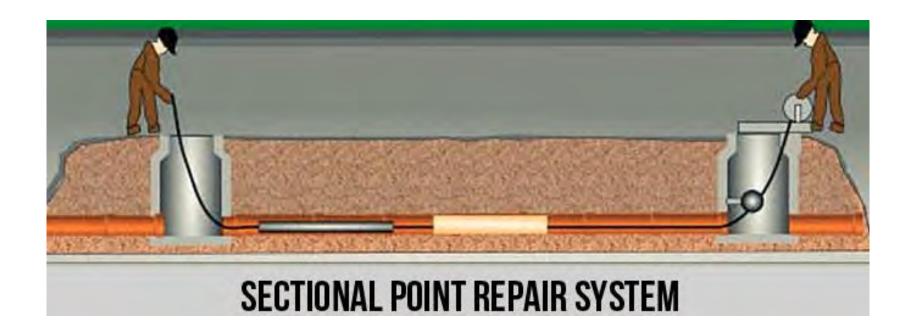
- Sectional CIPP Repair
  - C Typically requires two points of access, but in relatively short distances, can be performed with one point of access
