NASTT NE Regional Chapter
Trenchless Conference
Thursday, November 16, 2017

Moving Forward: Pipe Bursting and the
Administrator Approved Alternate for
Asbestos Cement Pipe

Edward Alan Ambler, P.E., LEED AP
Vice President, AM Trenchless

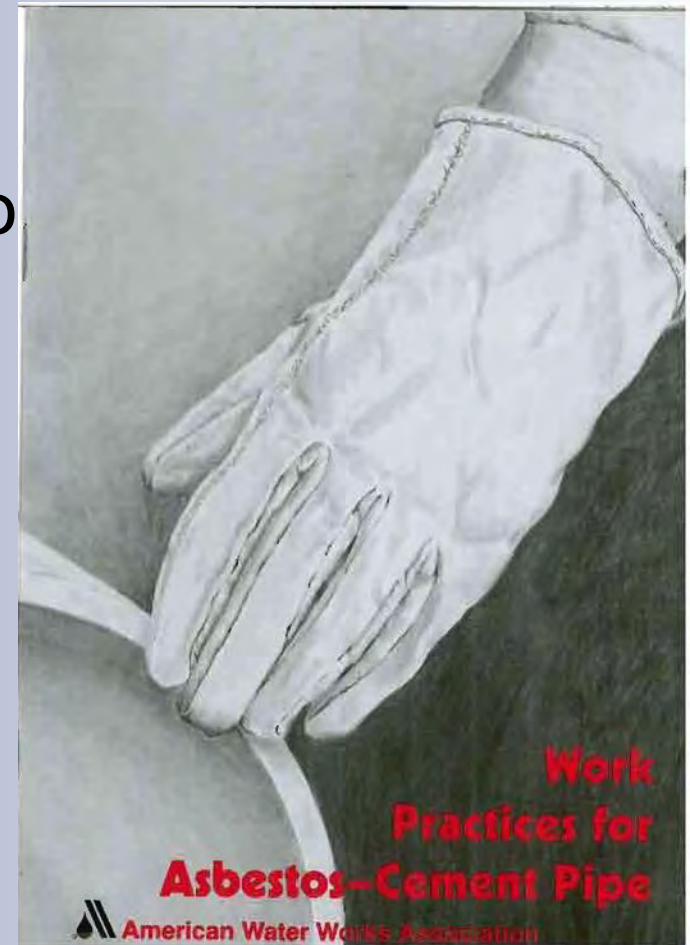
AWWA Work Practices for AC Pipe

- Keep the AC pipe wet
- Don't saw cut the AC pipe to release fibers
- Utilize a snap cutter on the AC pipe

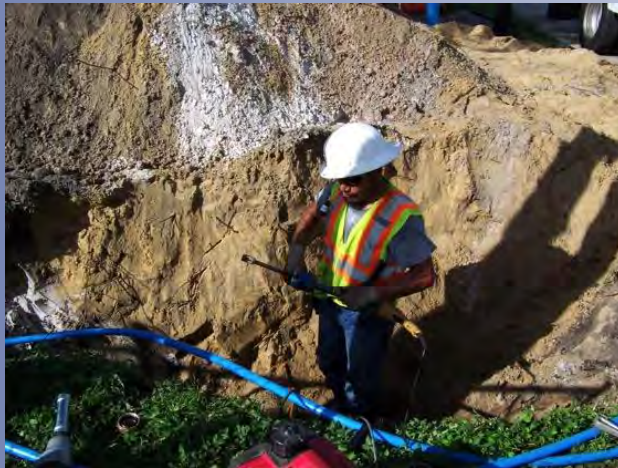
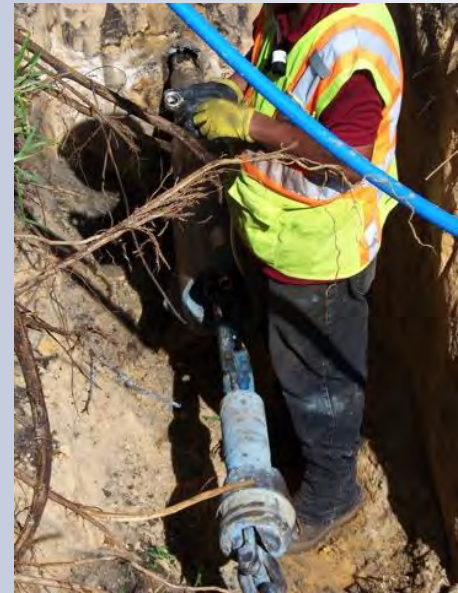
Asbestos Fibers During Rehabilitation

- Work during a recent pipe bursting projects in Boynton Beach, Florida performed an extensive Negative Exposure Assessment on the pipe bursting project
- Results indicated levels of asbestos ***under*** the limits set by OSHA

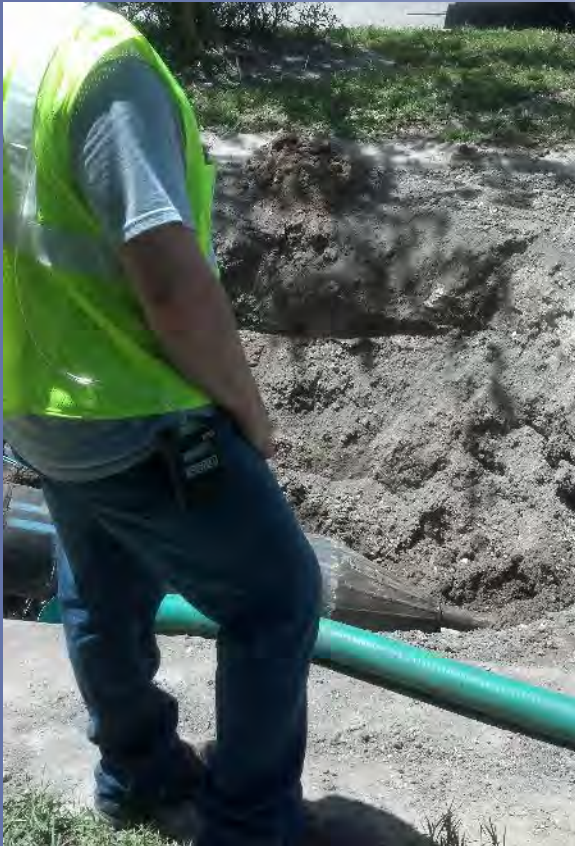
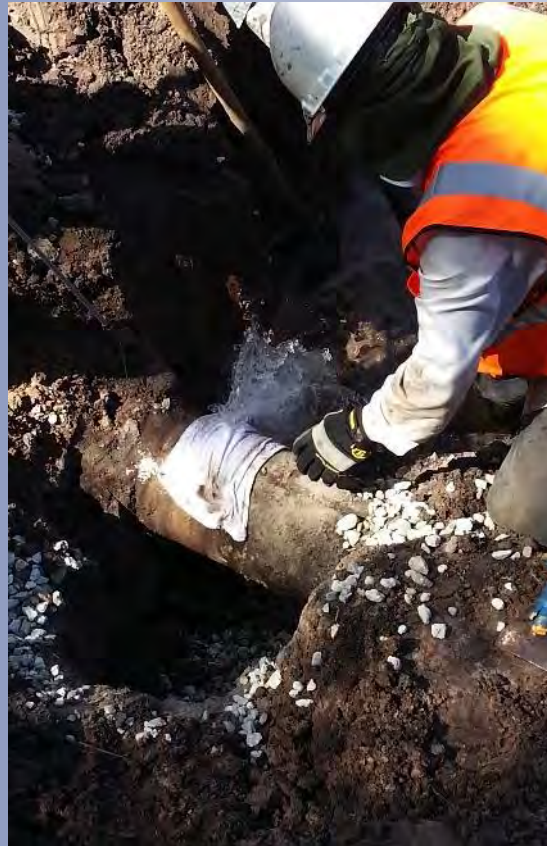
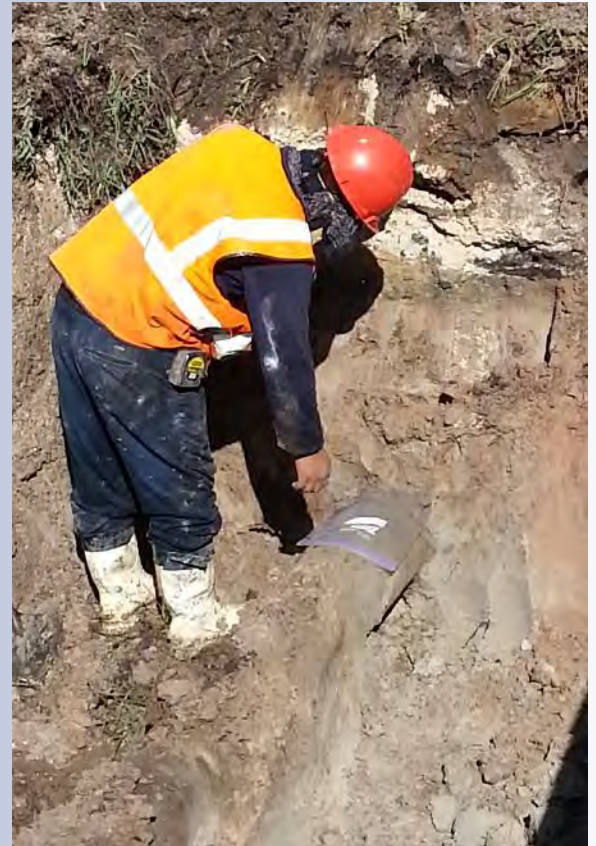
WRF #4465 - Environmental Impact Analysis

- Measured the asbestos in air, water, and soil

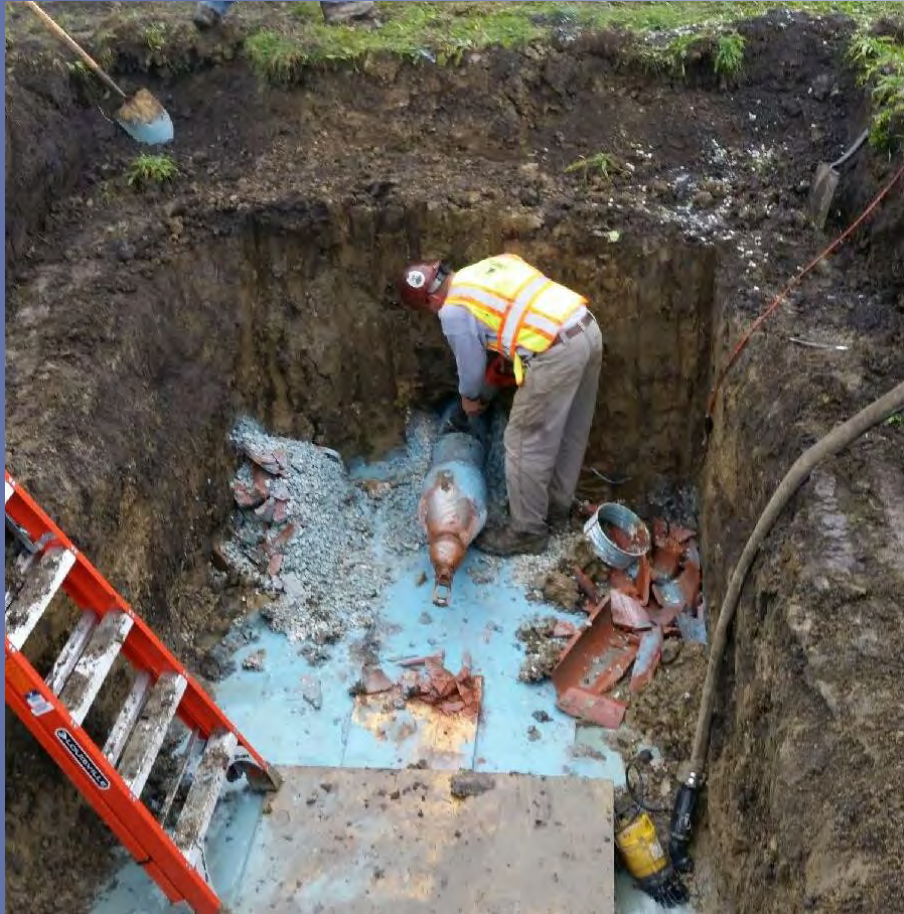
EncapsulAC

- Simple process and procedure added during pipe bursting activities
- Addition of a proprietary fluid that entombs remaining asbestos cement pipe fragments after pipe bursting
- Remaining coagulated mass is workable and does not harden like cement

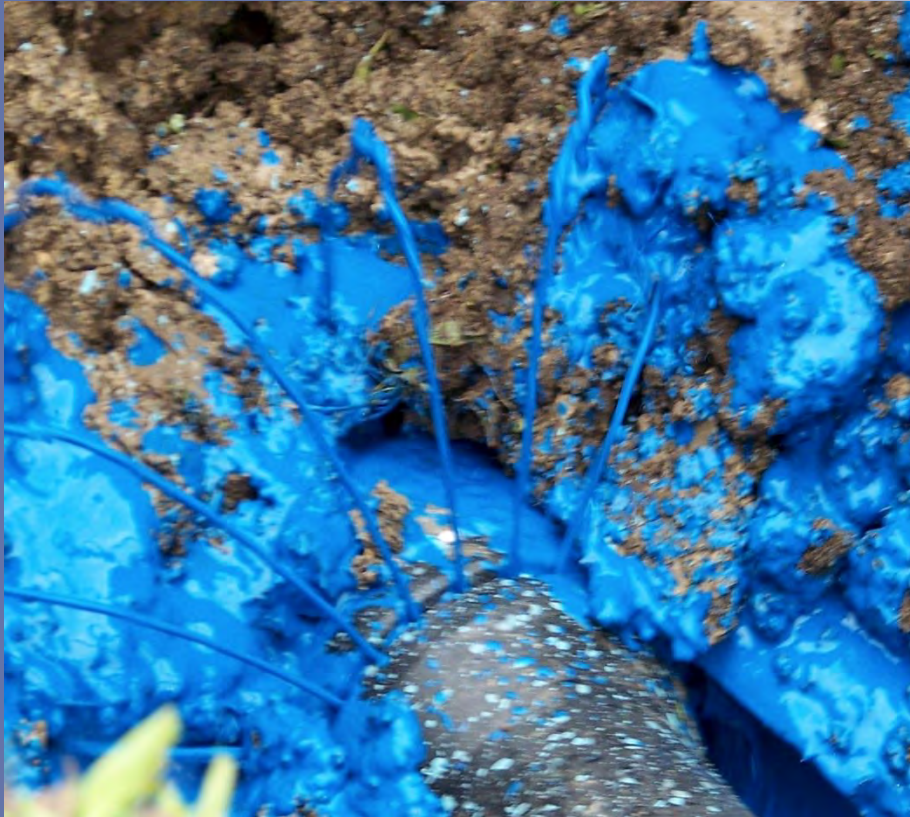
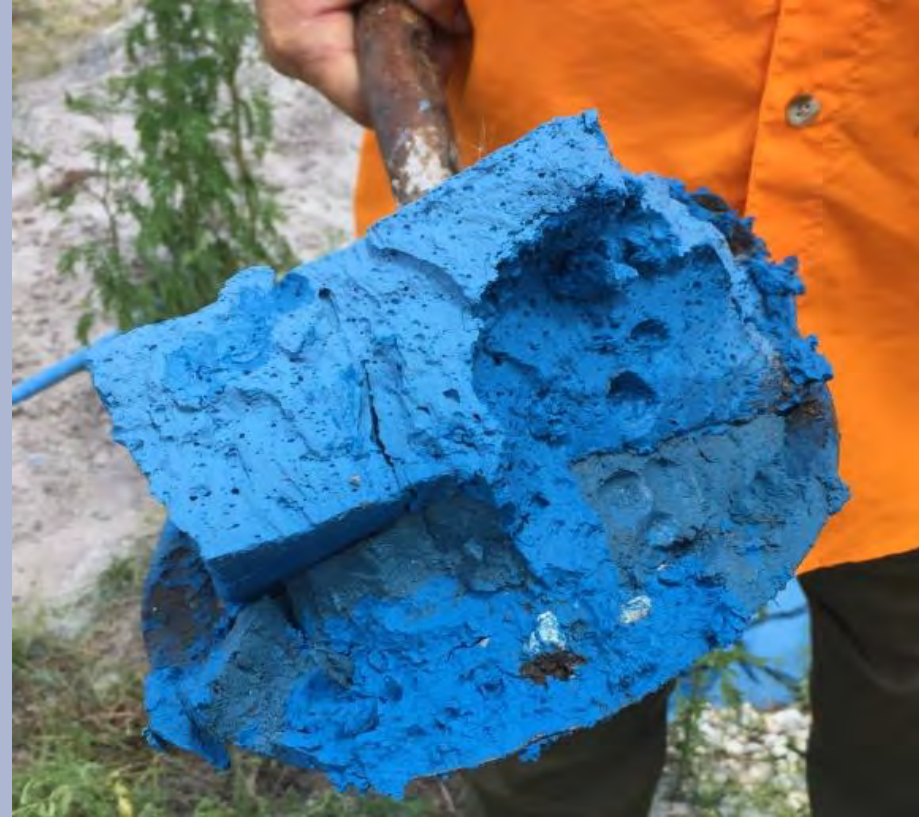
EncapsulAC

From pump-able fluid to
congealed mass in 24 hours

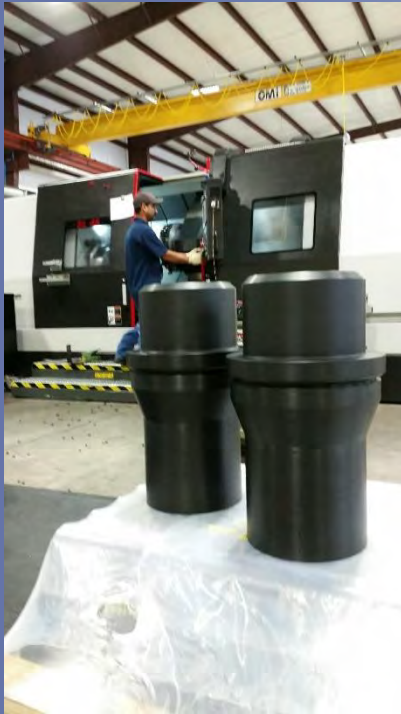
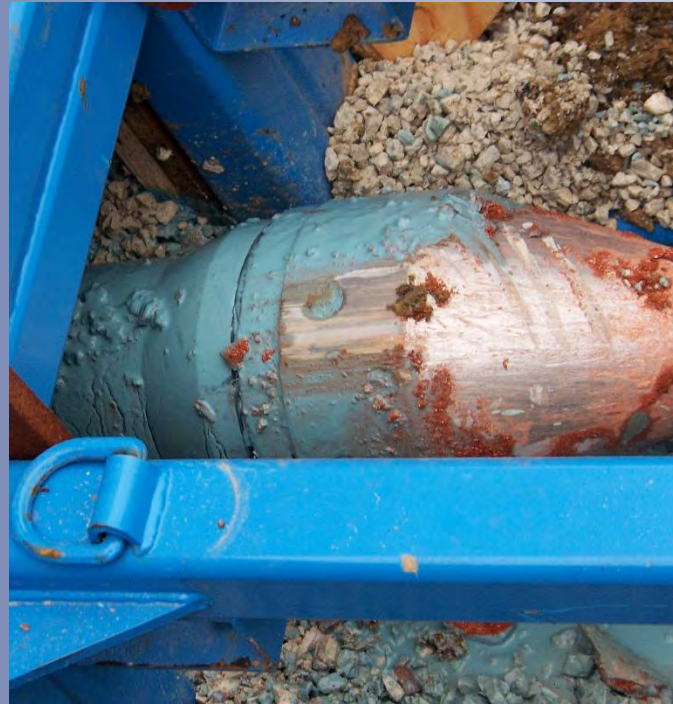
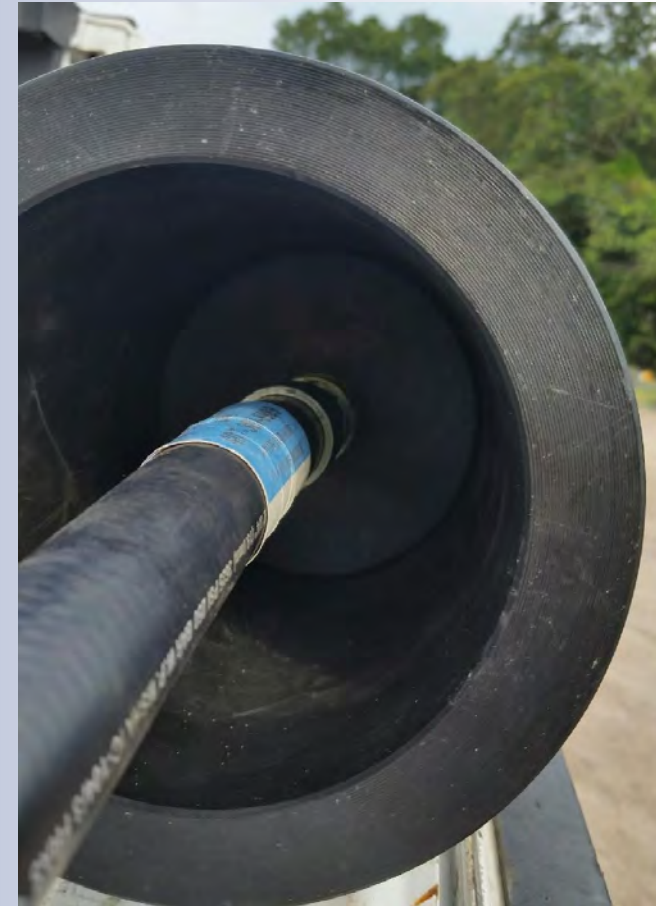
Delivery Systems Non Pre-Chlorinated Pipe

For non pre-chlorinated pipe bursting, the fluid delivery can be provided through the production pipeline

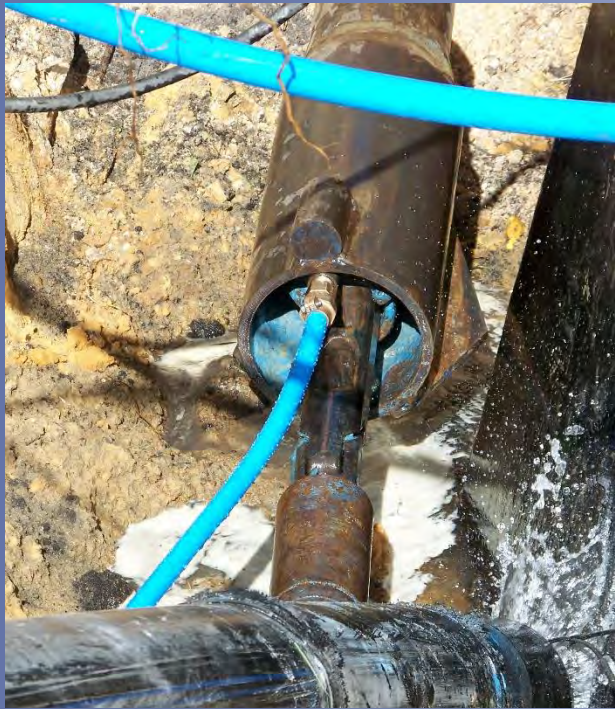
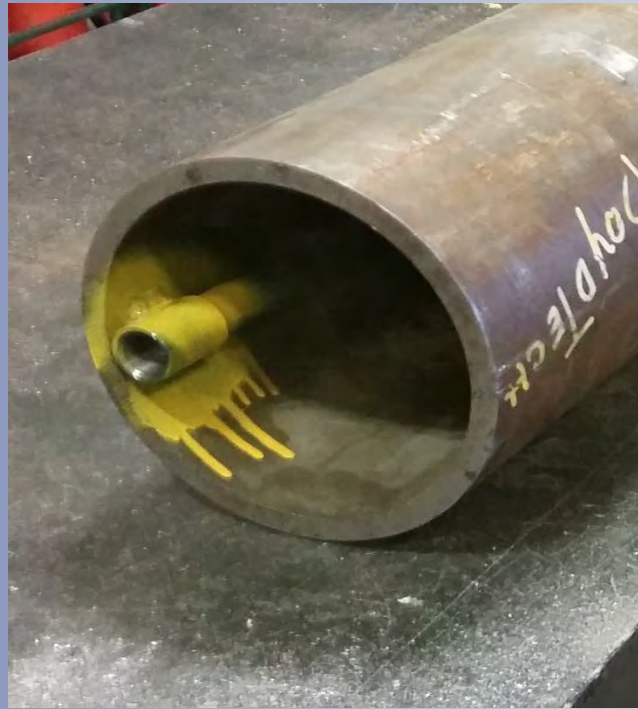
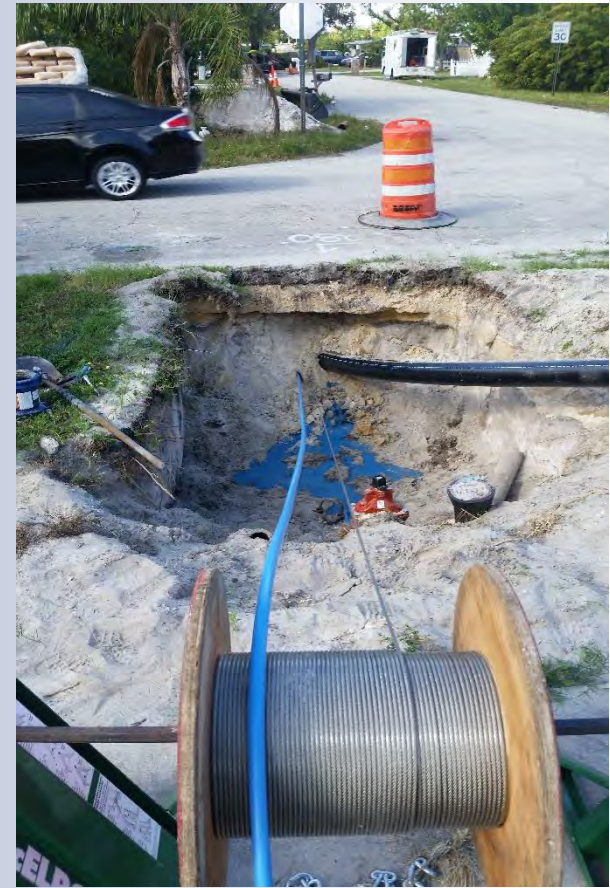
Delivery Systems Pre-Chlorinated Pipe

Fluid delivery outside of the production pipeline allows for pre-chlorinated pipe bursting

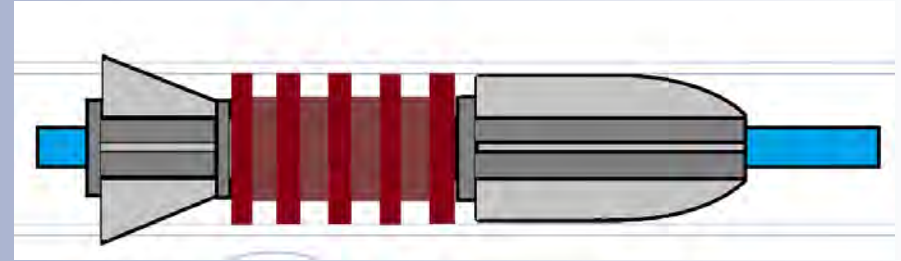
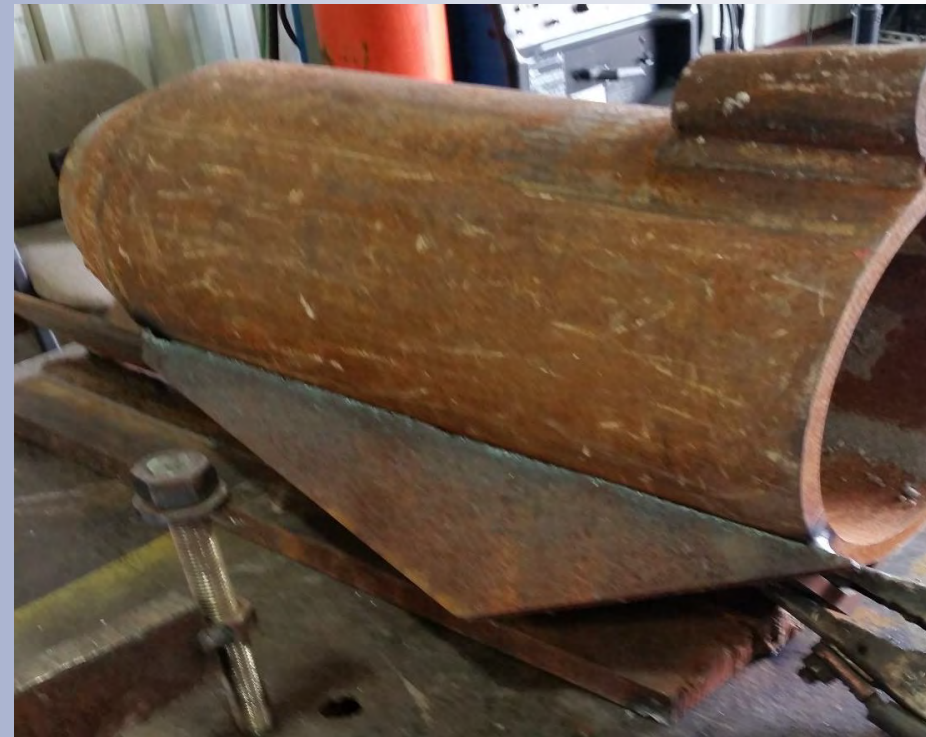
Fluid Distribution System

- A pigging system was needed in front of the expander head to coat all fragments with EncapsulAC
- Lower wings were added to resist rotation
- A dorsal sheave would provide a protected path for fluid delivery piping

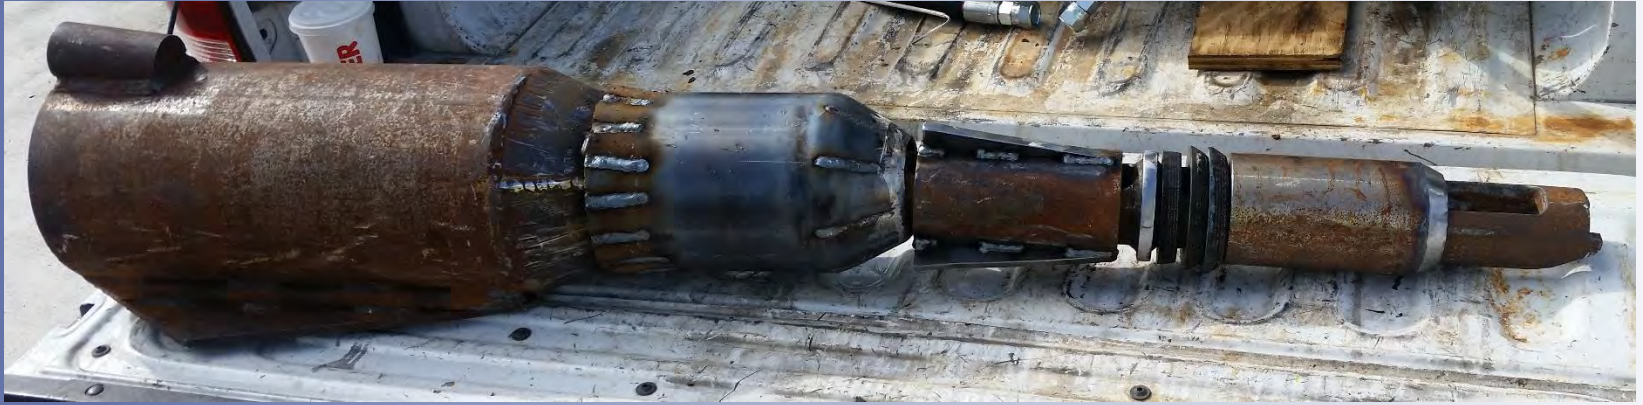
Fluid Distribution System

4" to 6" Burst Head
w/ Pig

6" on 6" Burst Head
w/ Pig
