A Multi-Community Approach for Addressing I/I

Presented by: Eric G. Schuler, P.E.

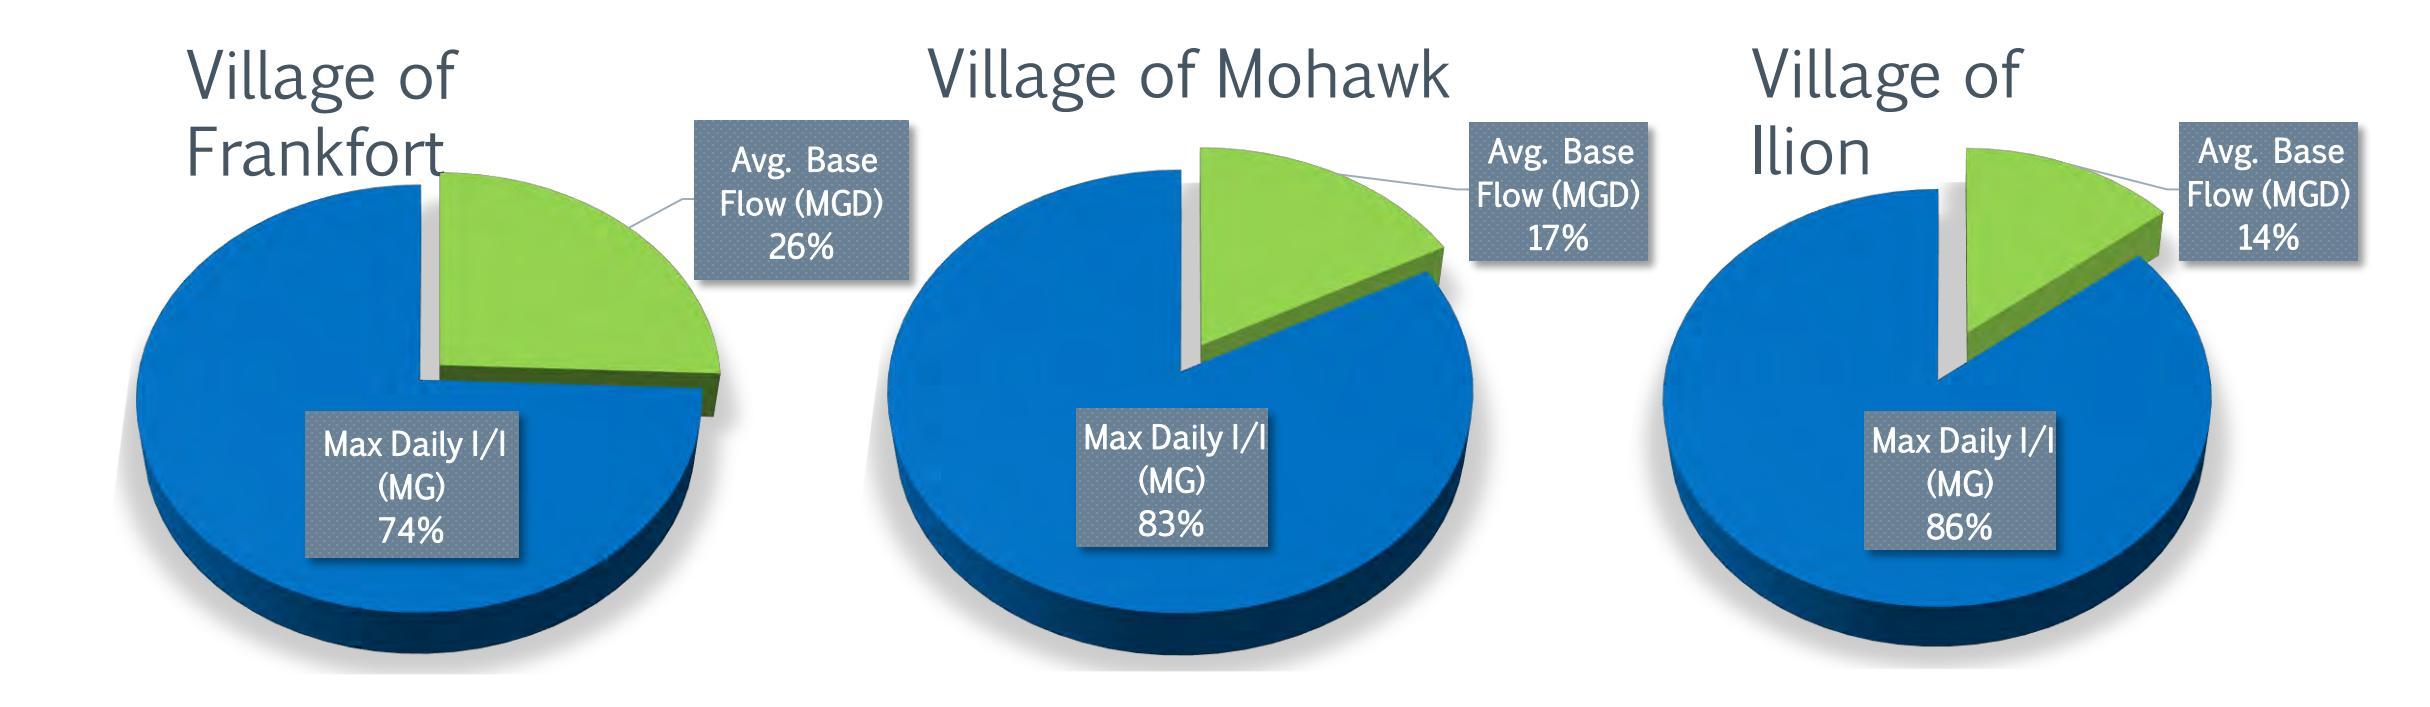
Wet-weather flow behavior...is there a trend?

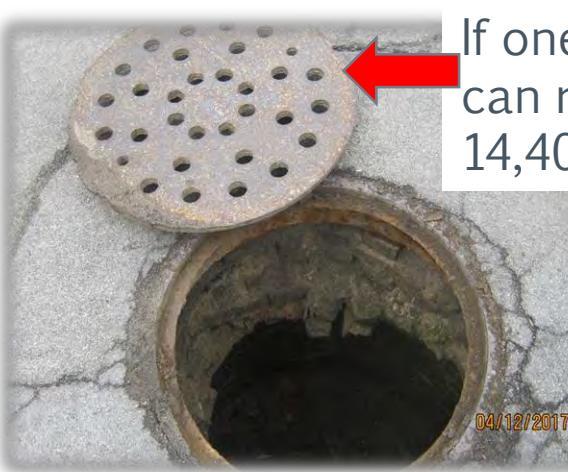
Manhole Inspections

If one 1.5" dia pickhole can result in over 14,400 gpd inflow...

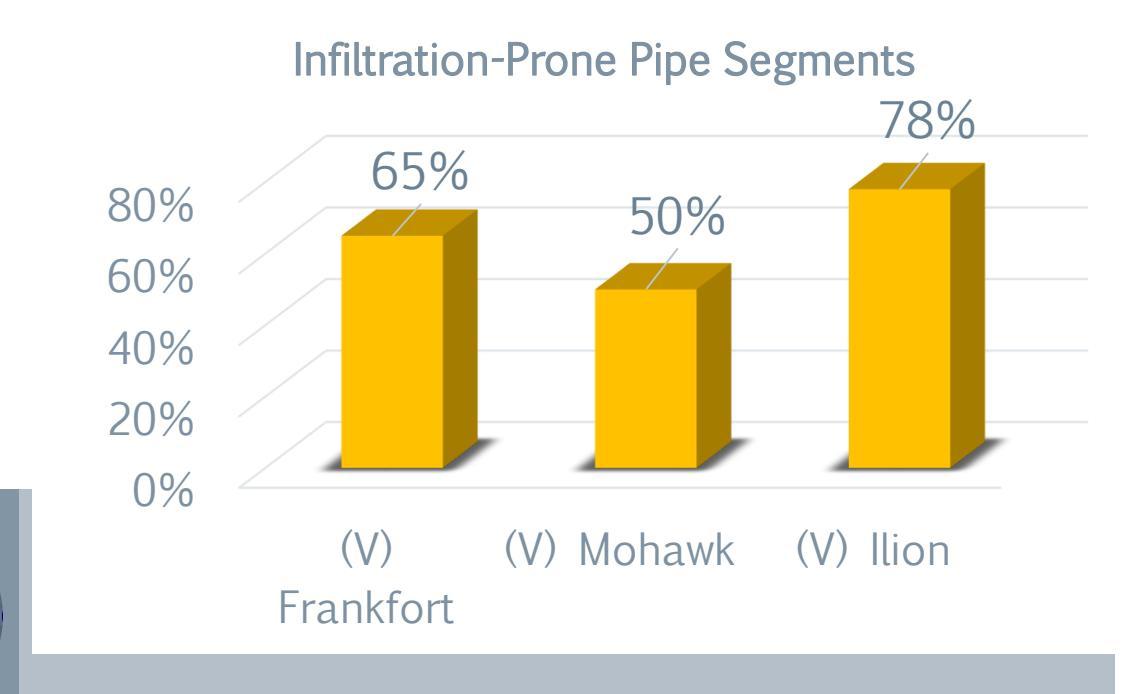
CCTV Inspections

- > PACP data export \rightarrow Lucity AM database
- Segment analysis based on defect severity level of infiltration

CENTIFIED WILE & DUE CONTRA	CT0#			Fax: E-mai	E	
		Inspecti	on Report			
Date 6/5/2017	P/O. No.	Weather Dry	Surveyor's Name J. McKinney	Pipe Segment Reference	Section No. 1	
Certificate No.	Survey Customer	System Owner	Preset :	Pre-Cleaning No Pre-Cleaning	Sewer Categor	
Morgan Use of Sever Sa City Ilion Drainage Area Loc. details Flow Control Flow Control Location Code Main Highway - Urban Length surveyed 17			tary 05 ft	Upstream MH. 24217 Dowstream MH 24225 Dir. of Survey Downstream Section Length 170.05 ft		
Purpose of Survey Year Laid Year Rehabilitated Tape / Media No. Add. Information :	Maintenance Related		Joint Length Dia./Height Material Lining Method	8 inch Vitrified Clay Pipe		
24217	<u>0.00</u> Manhol <u>19.06</u> Water L <u>37.80</u> Crack C <u>41.90</u> Repair <u>89.96</u> Tap Bre <u>89.96</u> Fractur <u>89.96</u> Infiltrati <u>96.69</u> Tap Bre <u>96.69</u> Infiltrati	e, 24217 Level, Sag in pipe, 5 % o Dircumferential, from 8 o' Pipe Replaced Pak-In Active, at 3 o'clock e Multiple, from 9 o'clock on Runner, at 12 o'clock on Runner, at 9 o'clock on Runner, at 9 o'clock	f cross sectional area clock, to 4 o'clock s, 4 inch dim s, to 3 o'clock s, 4 inch dim		04.27 FT
